# Salvaging Of the Costa Concordia

A PRESENTATION by ASHUTOSH Patel ,AVINASH Gupta and VISHNU Ramdas

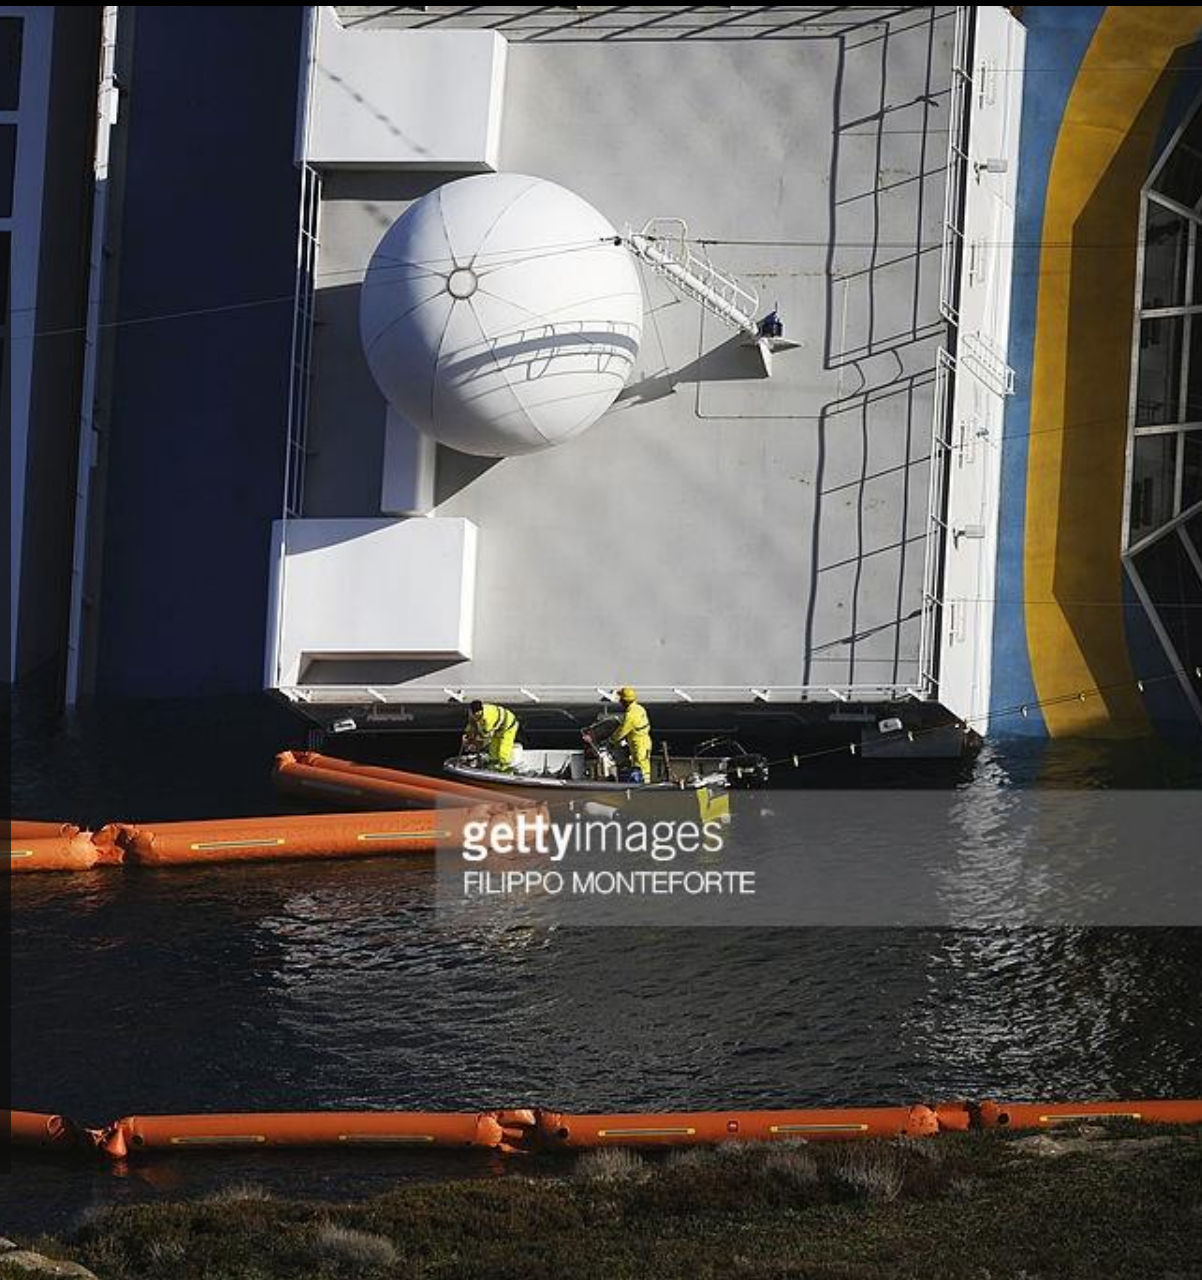
# Step 1

The ship was surrounded with floating barriers to stop oil from spreading into the sea. As oil floats any leakage would stay on the surface.

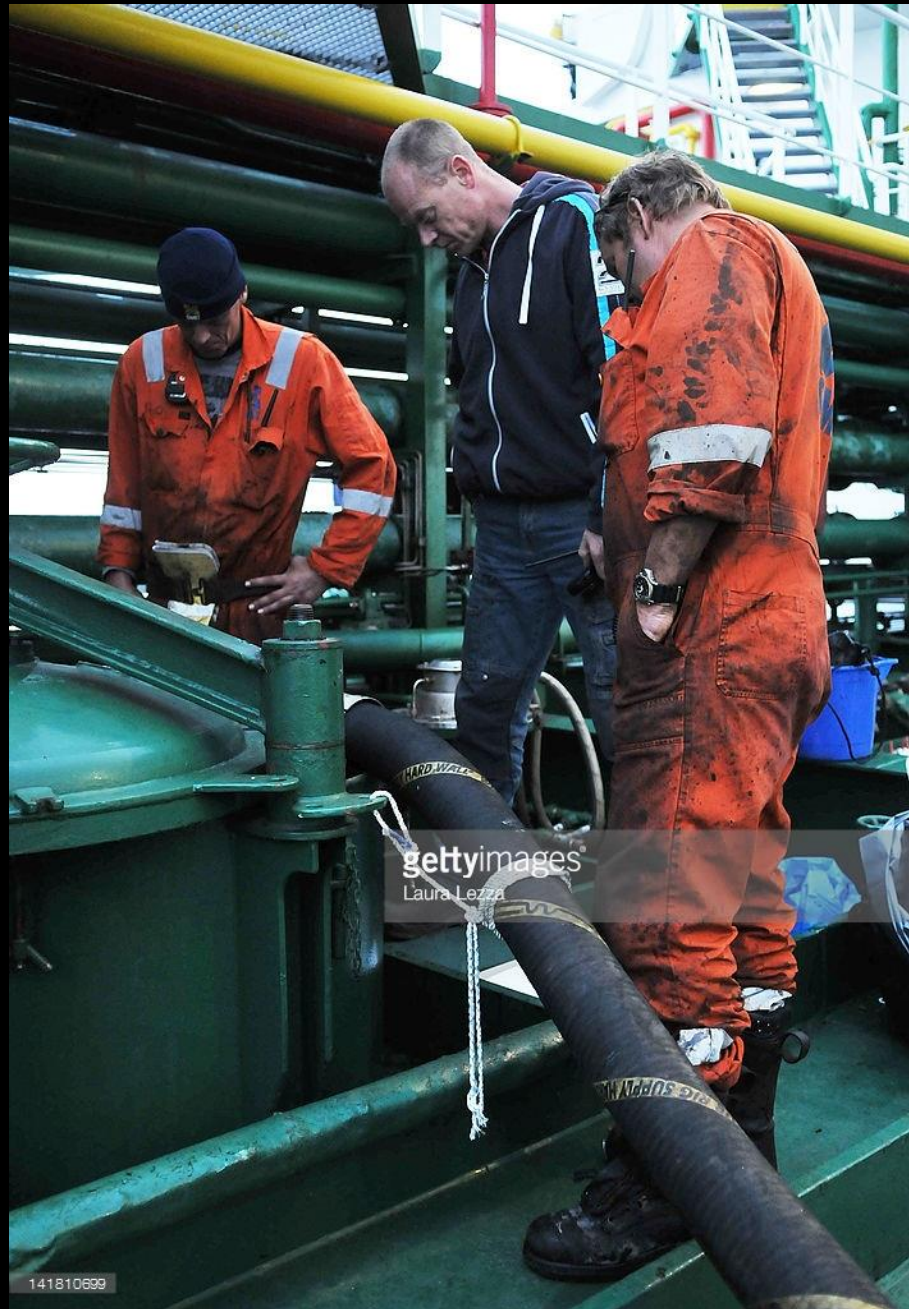
# Step 2

The next job was to remove the oil out of the ship's fuel tanks. Pumper ships pumped the oil to a carrier ship, which carried the oil to a tanker out at sea.

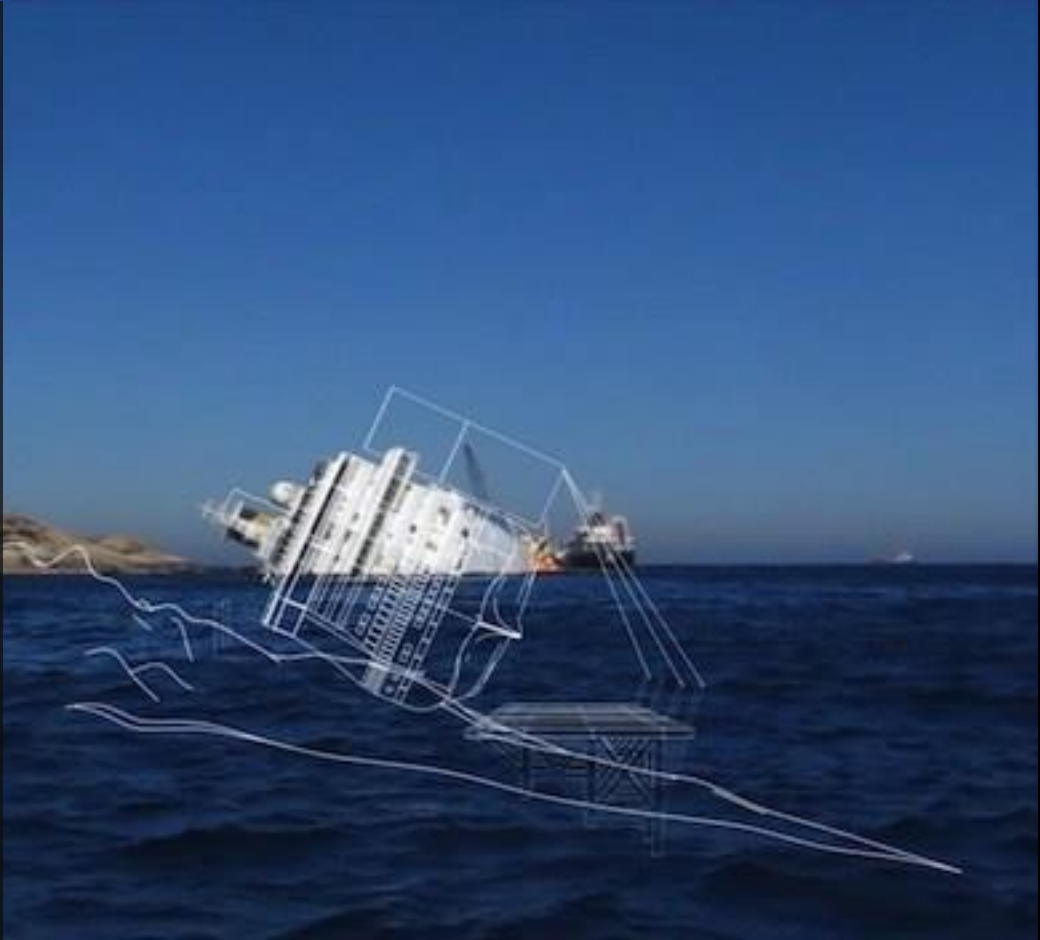
# Step 3

Six platforms were built under the ship, on which the ship was to be straightened.

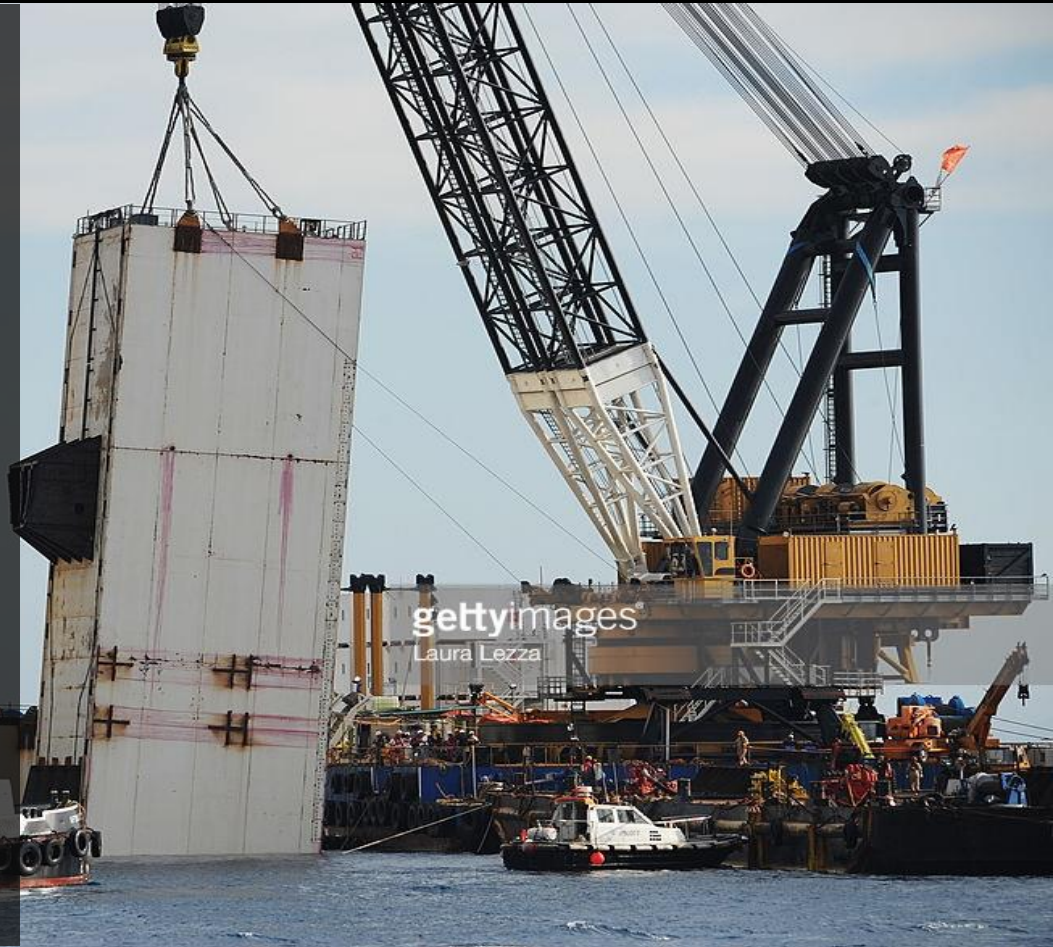
# Step 4

Then sponsons were welded on to the dry side of the ship. These sponsons increase the buoyancy of the ship.

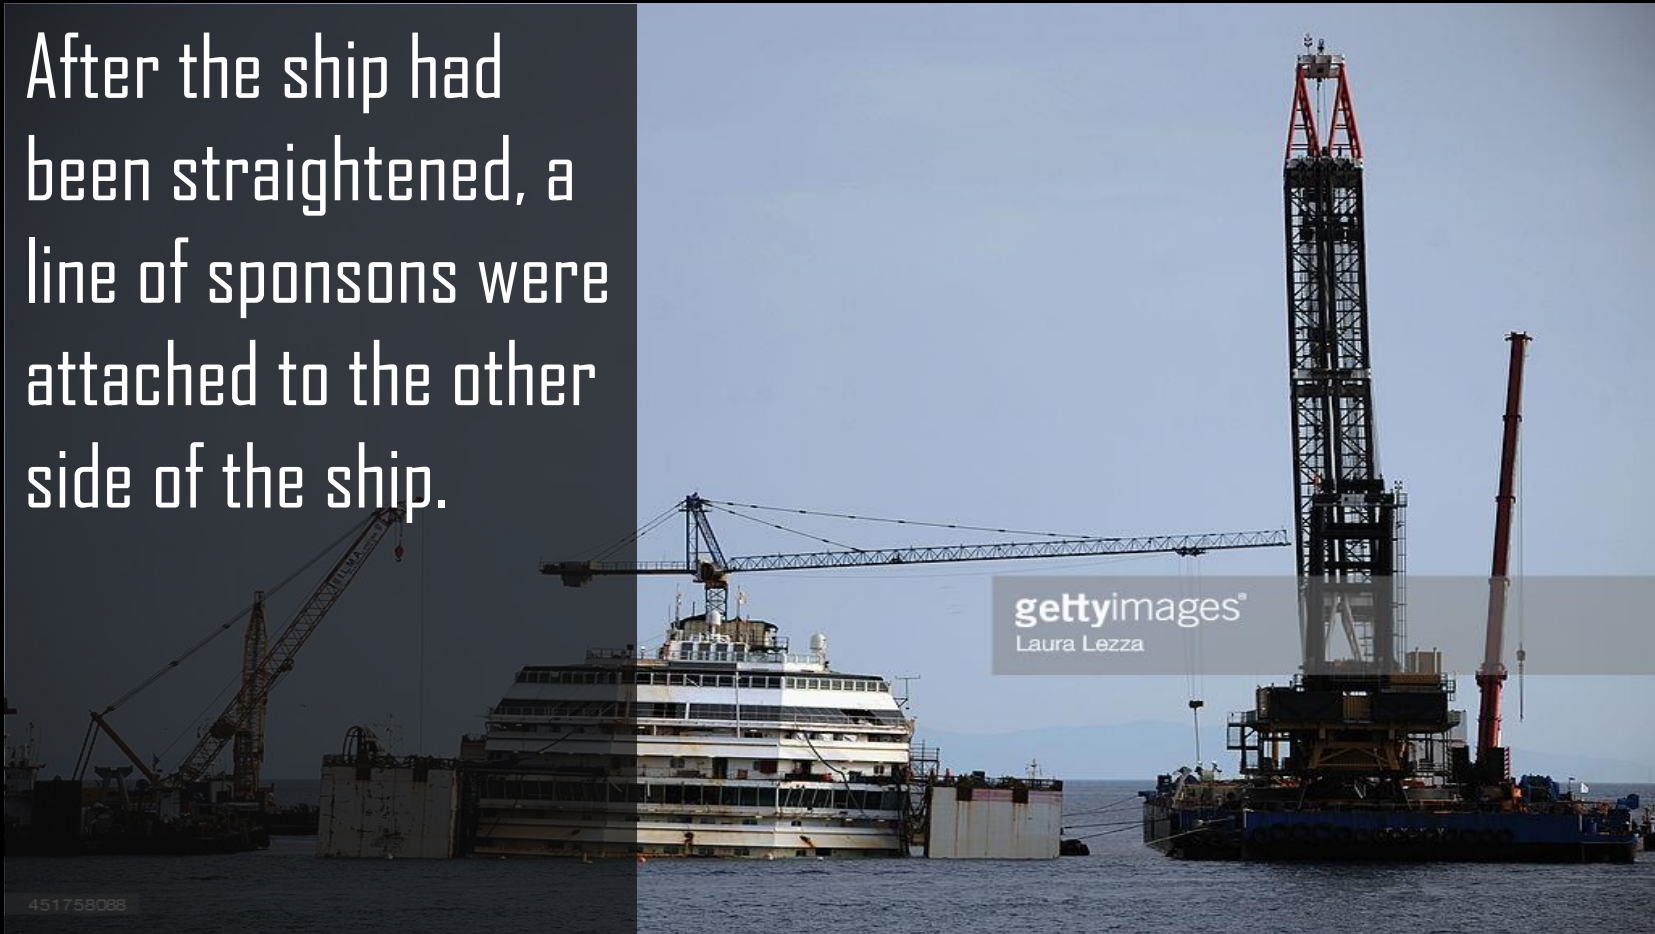
# Step 6

After the ship had been straightened, a line of sponsons were attached to the other side of the ship.

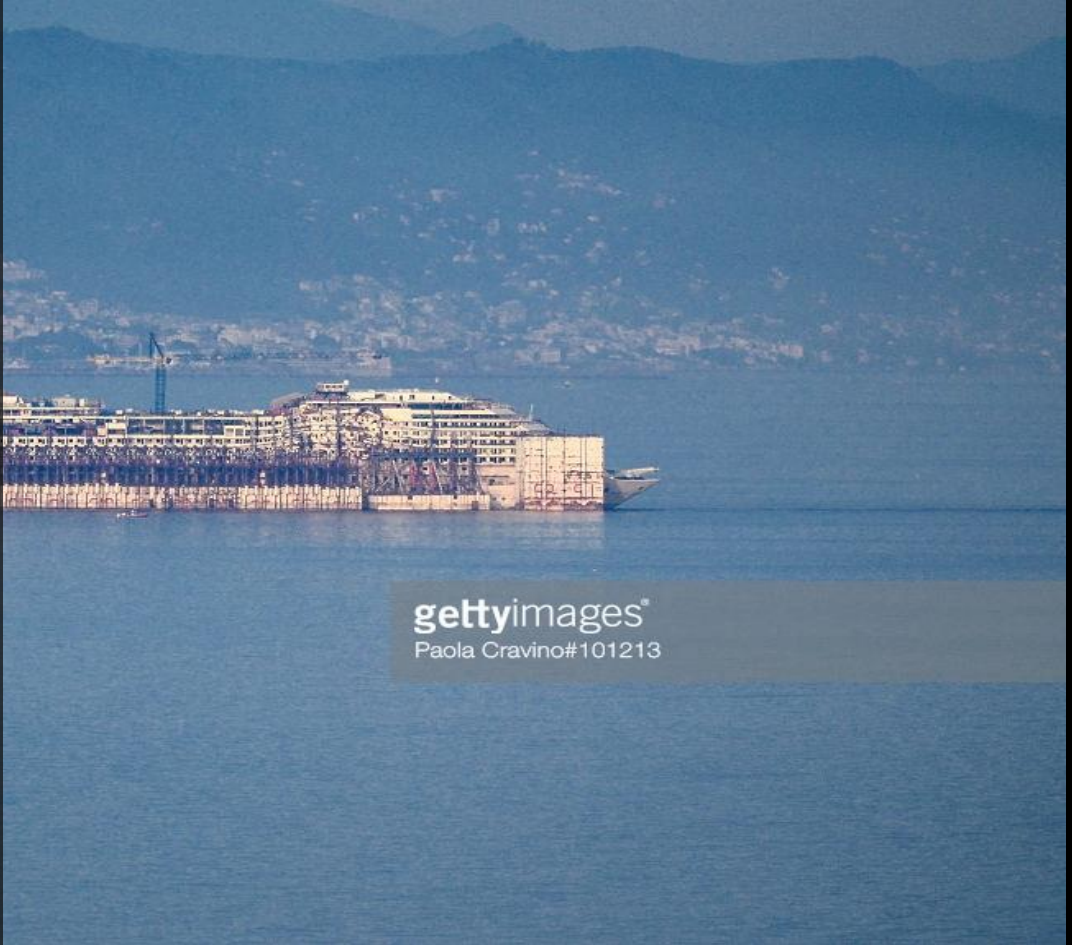
# Step 7

All the water was pumped out of the sponsons. Due to the added buoyancy of the sponsons, the ship slowly started refloating.

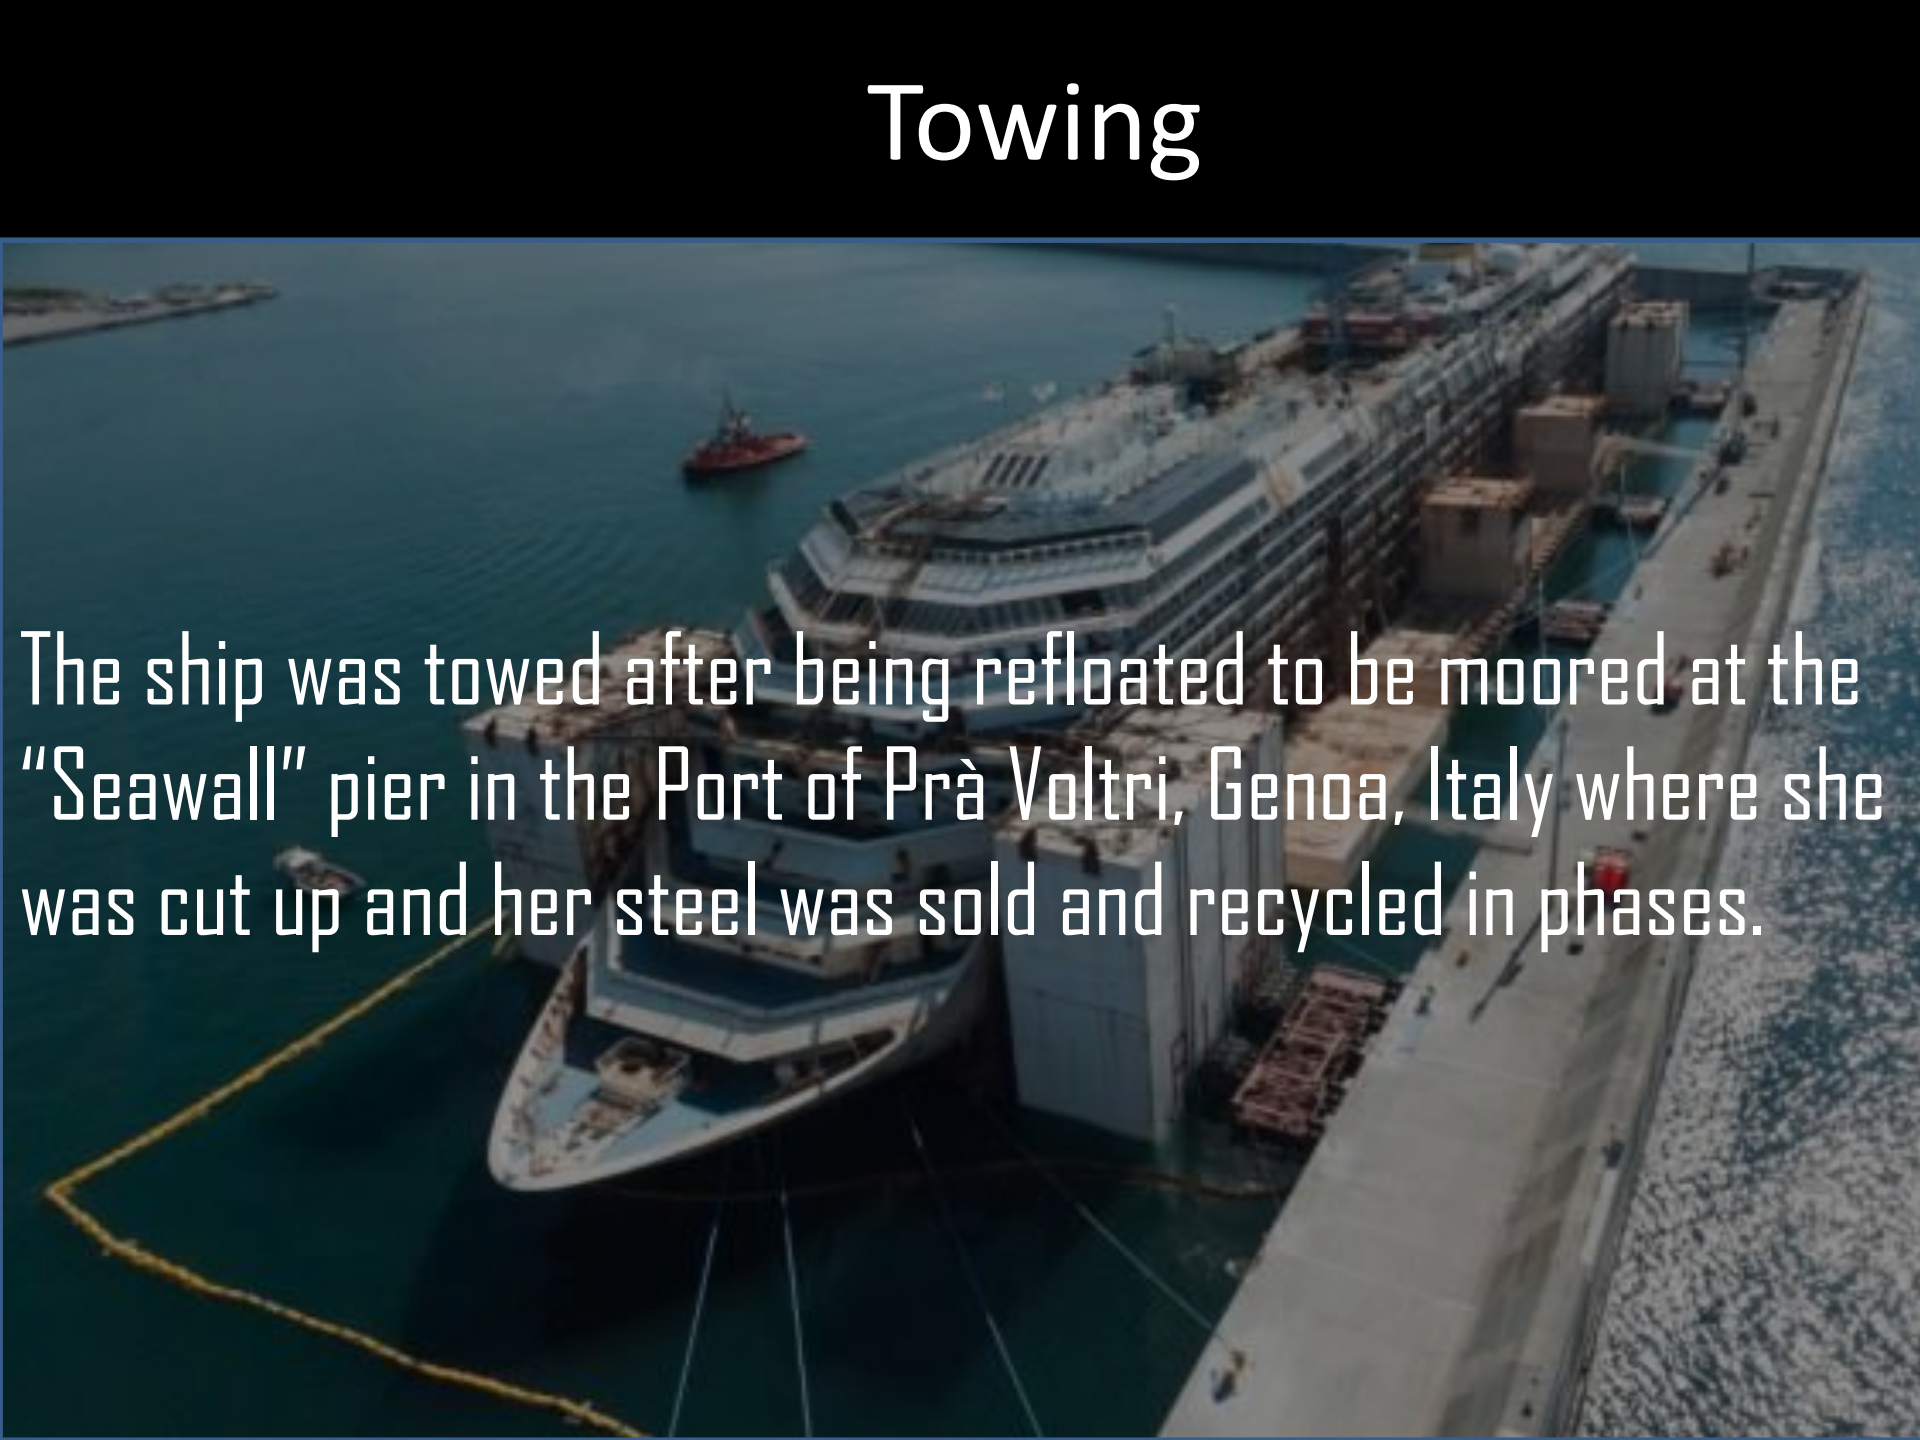
# Towing

An aerial photograph showing a large, multi-decked cruise ship being towed by a tugboat in a harbor. The ship is positioned alongside a long, narrow pier. The water is a deep blue-green color. The ship's hull is white, and its upper decks are visible. The tugboat is a smaller, red-hulled vessel positioned to the left of the cruise ship. The pier is a long, concrete structure extending into the water. The overall scene depicts the process of towing a large vessel in a port.

The ship was towed after being refloated to be moored at the "Seawall" pier in the Port of Prà Voltri, Genoa, Italy where she was cut up and her steel was sold and recycled in phases.
