_____Road Safety Audit of Accident Prone Locations in Bhopal City

Project: - Road Safety Audit of Hoshangabad road from Regional Research Laboratory to Misrod.

Project: - Road Safety Audit of Raisen road from Jinsi to Bhanpura over-bridge via Piplani.

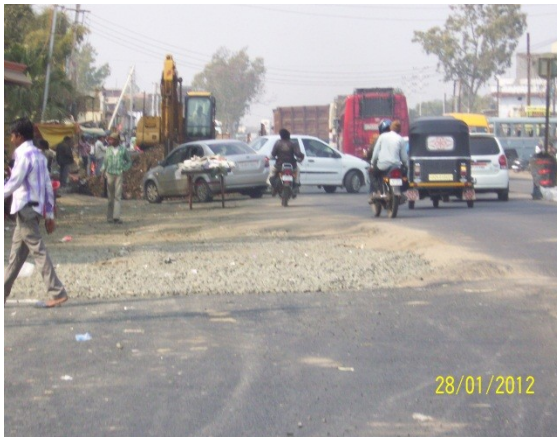
Figure-2 No advance warning signs

| 1. | No Advance information regarding approaching construction zone | <ul style="list-style-type: none"> • Approach transition zone should be provided • Advance warning signs should be installed at least 50 m before the hazardous location. | Refer appendix, fig.2,IRC:S P 55-2001 and IRC 67-2001 |

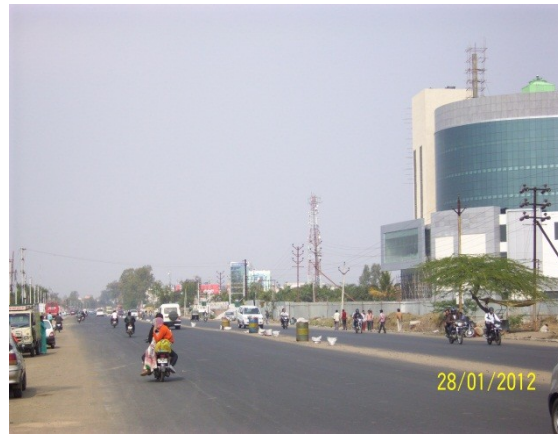
Figure-3 No Street lighting and markings

| 3. | No Street Lighting hindering night time visibility | <ul style="list-style-type: none"> • Adequate street lighting of sufficient intensity should be provided. • Additional lighting (such as halogens) should be provided at work zones | Refer appendix figure 3 |
| 5. | No provision of marked lanes for safe and clear guidance of traffic | <ul style="list-style-type: none"> • Provide White lines of 15cm width at places where there is no median • Provide Broken single white lines of width 10cm and length 3m to divide | Refer appendix figure 3 and IRC:35-1997 |

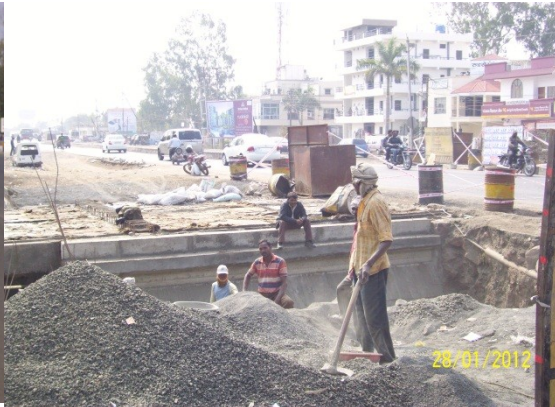
Figure-5 Cyclists forced to move on main carriageway

12.	Cyclist are forced to ride on main carriage way	<ul style="list-style-type: none"> Separate lane of 2.0m should be provided or Service road of minimum 	Refer IRC: 86

5.5m should be provided

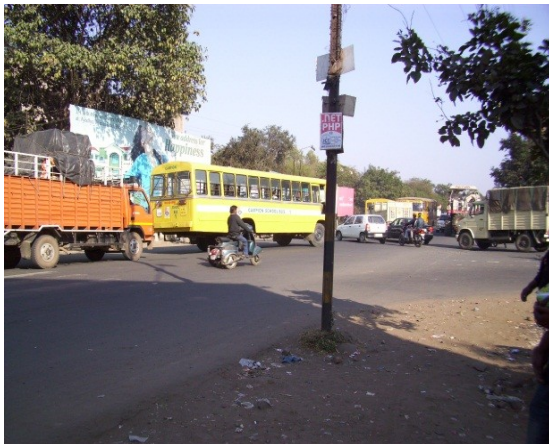
Figure-6 Conflicting Situation due to improper layout of ITI intersection

S. No.	Selected Safety Issue(As per Suggestions IRC: SP 88, 2010)		Remarks
1.	Poor surface and carriage way markings	<ul style="list-style-type: none"> Provide necessary markings such as edge marking, centre line marking, object marking etc. 	Refer IRC: 35-1997
2.	Inadequate street lighting	<ul style="list-style-type: none"> Adequate number of street lights should be provided High mast lights should be provided at junctions 	-
3.	Inappropriate width of medians and markings	<ul style="list-style-type: none"> Minimise median openings. Medians should be marked with alternate white and black strips with retro-reflective paint 	IRC:35-1997
4.	General layout of junction does not caters safety for all road users	<ul style="list-style-type: none"> a rotary is required at Ayodhya junction and ITI intersection 	Refer appendix, fig.6 and

(ITI Trisection, Ayodhya Junction)		IRC: 86-1
5.	Presence of petrol pumps at junctions	<ul style="list-style-type: none"> Relocate the petrol pumps 	Refer “manual for safety in road design”

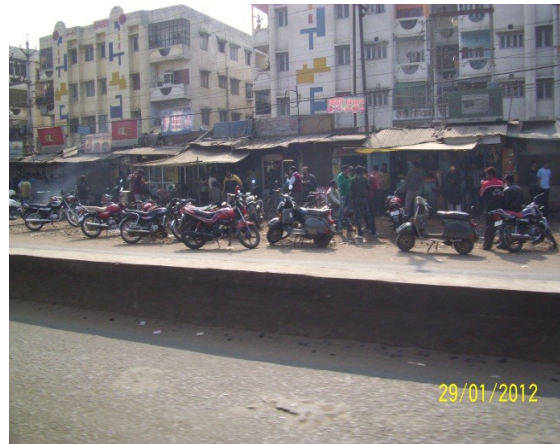
Figure-7 Haphazard on-street parking

6.	No satisfactory provision for parking	<ul style="list-style-type: none"> Proper off street parking should be there Prohibit on-street parking 	Refer appendix, fig.7

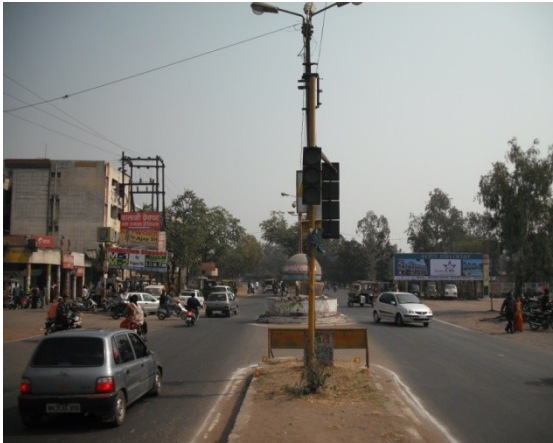
Figure-8 Pedestrians crossing in unsafe Environment

9.	Poor condition of traffic signs	<ul style="list-style-type: none"> Traffic signs should be of proper standards 	Refer IRC:35-1997
11.	No adequate provision for pedestrians at hazardous places	<ul style="list-style-type: none"> Provide foot over bridges, pedestrian signal and subways at hazardous places 	Refer appendix, fig.8

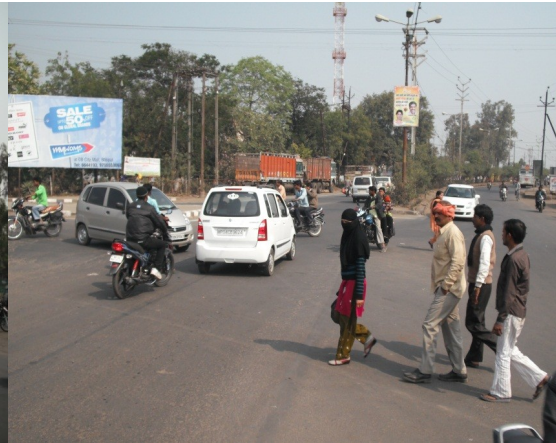
13. Non-functioning traffic signals

Figure-9 Non-functioning traffic signals

- Install new signals with proper synchronisation Refer appendix, fig.9
- Mount over-head signals
