INTEGRATED CONDITION MONITORING TECHNOLOGIES FOR ENERGY SAVING APPLICATIONS

TRANSTECH
CONFERENCE
2018, PUNE

GREEN SAILS SINGAPORE CONDITION MONITORING TECHNOLOGIES FOR MARINE, OFFSHORE AND INDUSTRY

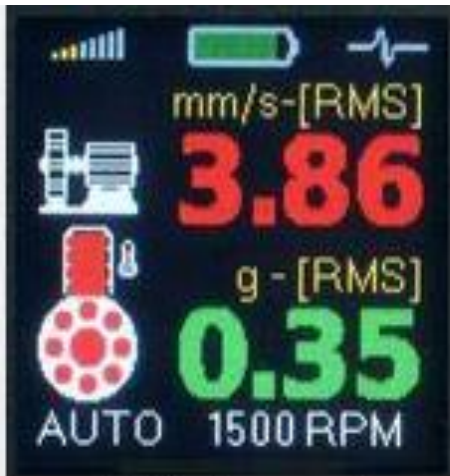
RMS values and temperature of bearing

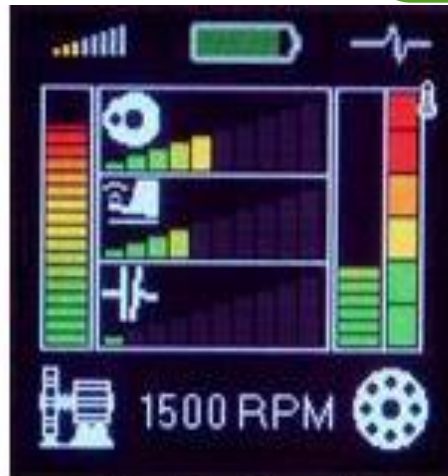
Machine Expert

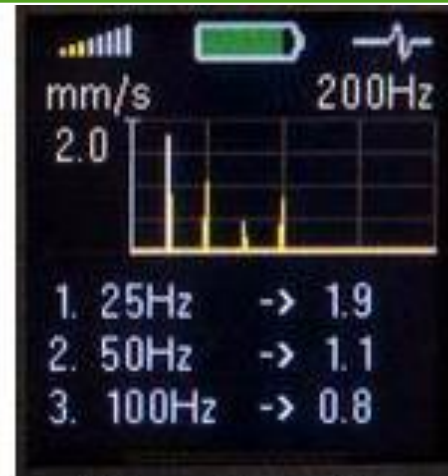
FFT spectrum with peaks detection

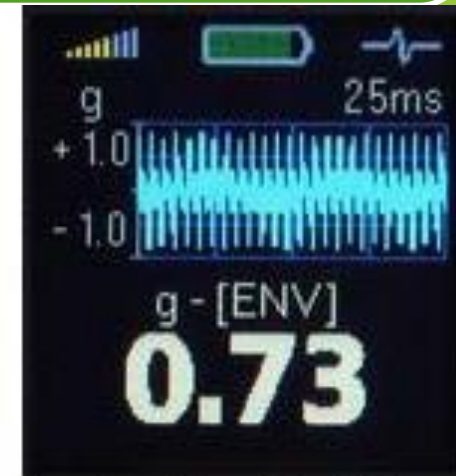
Acc time signal for bearing condition

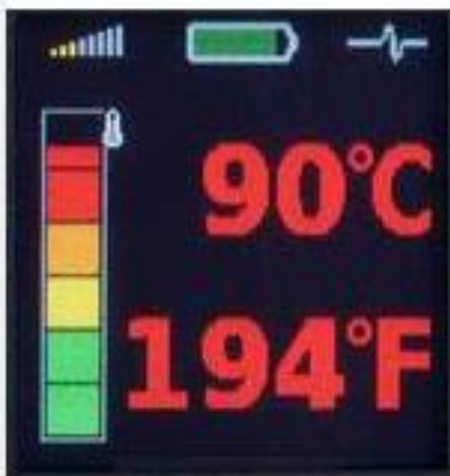
Temperature

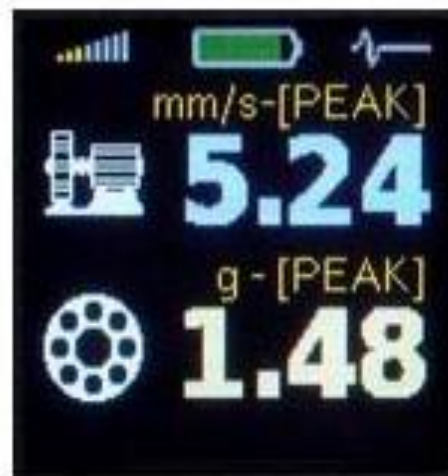
Peak values

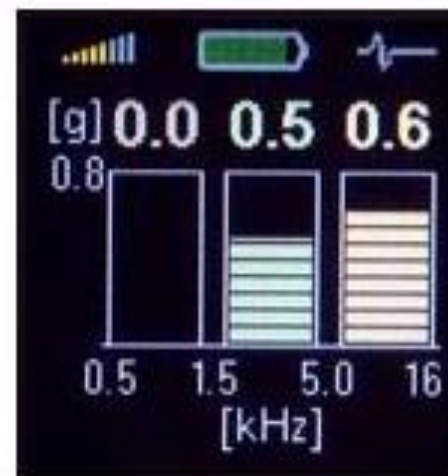
Acc band values

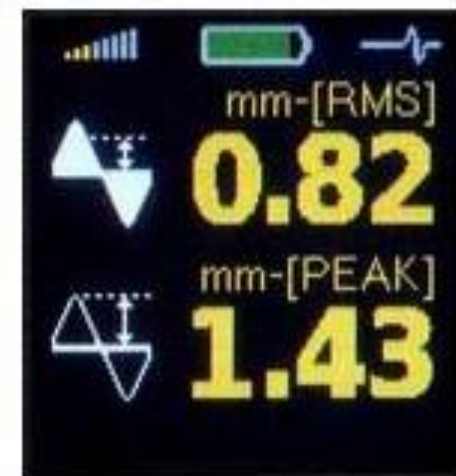
Displacement values

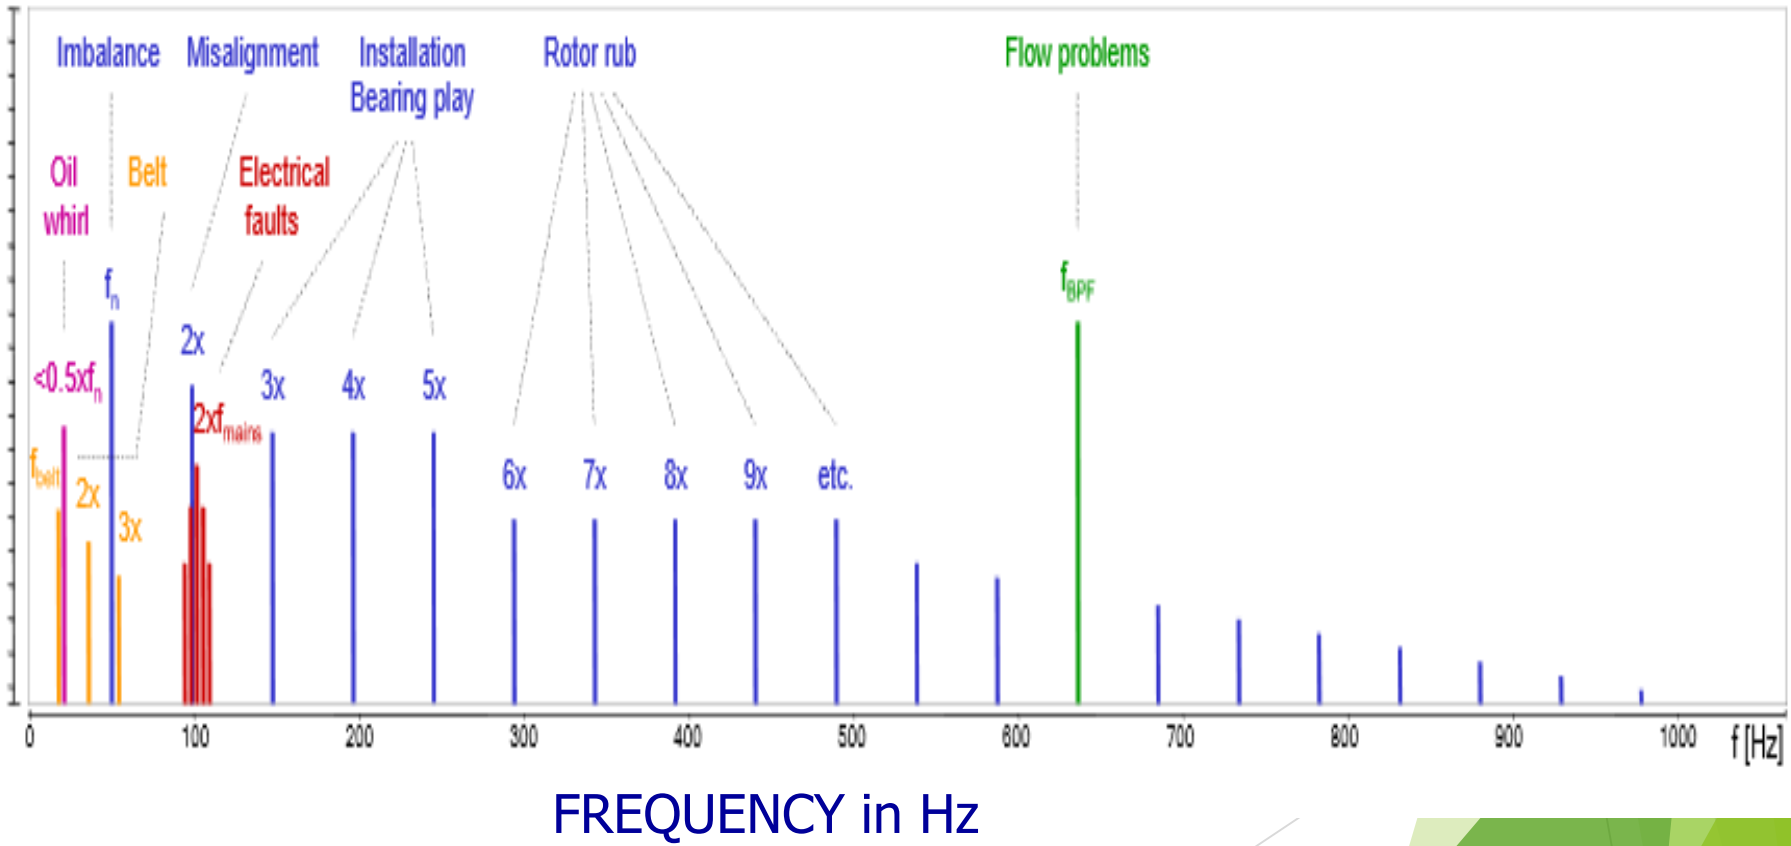
FFT Spectrum in **Velocity** Vibration and the possible faults can identify from the spectrum

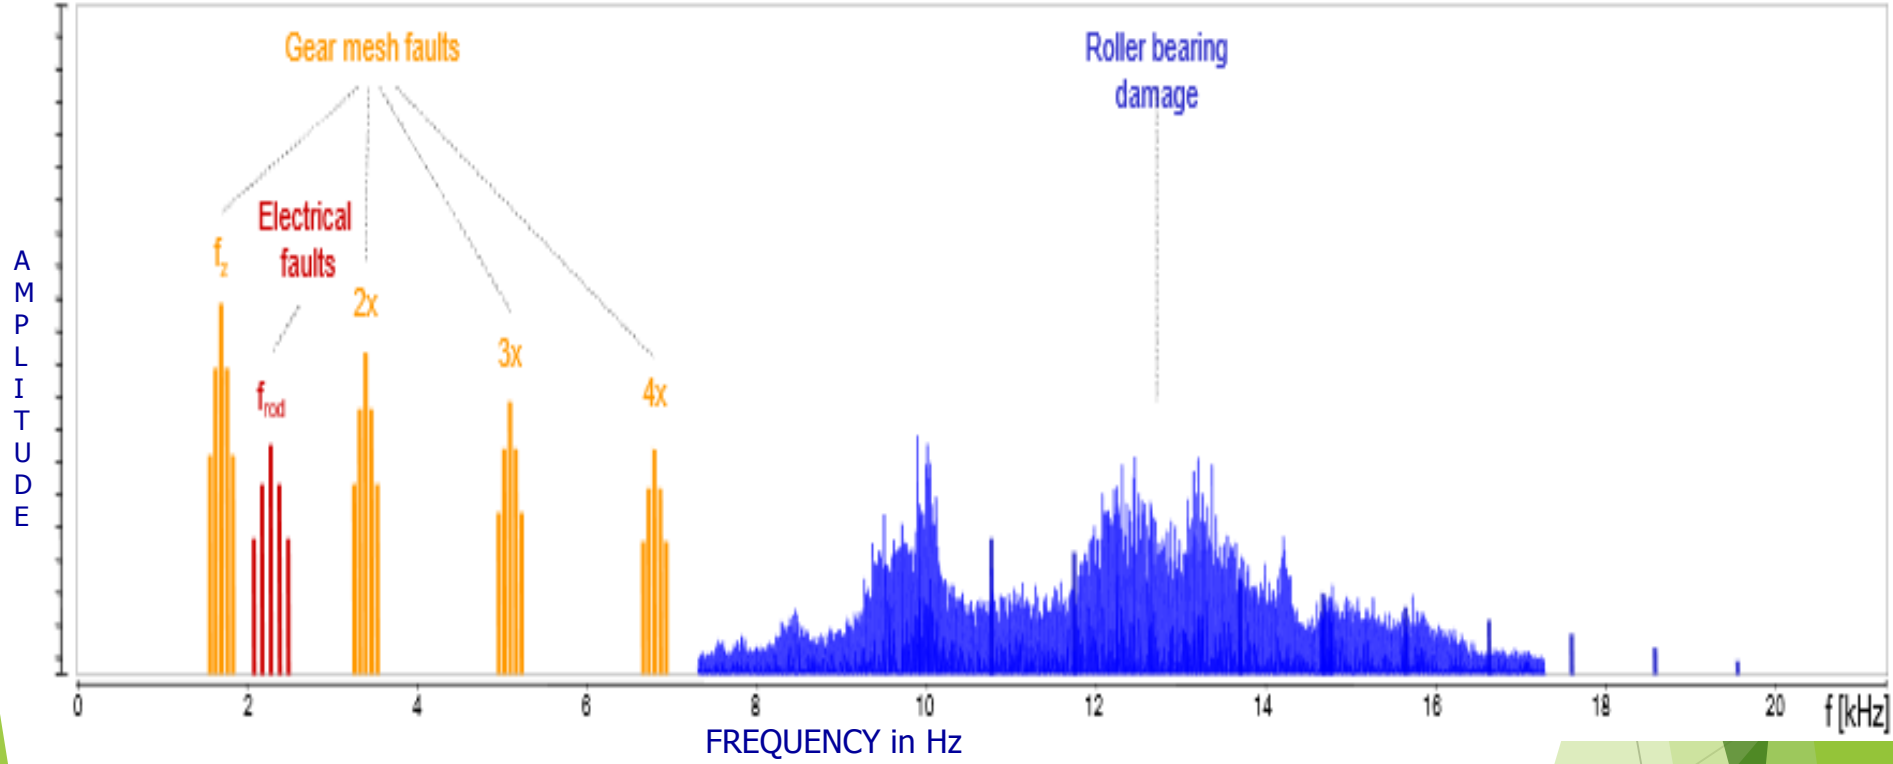
Vibration analysis in Acceleration broadband spectrum

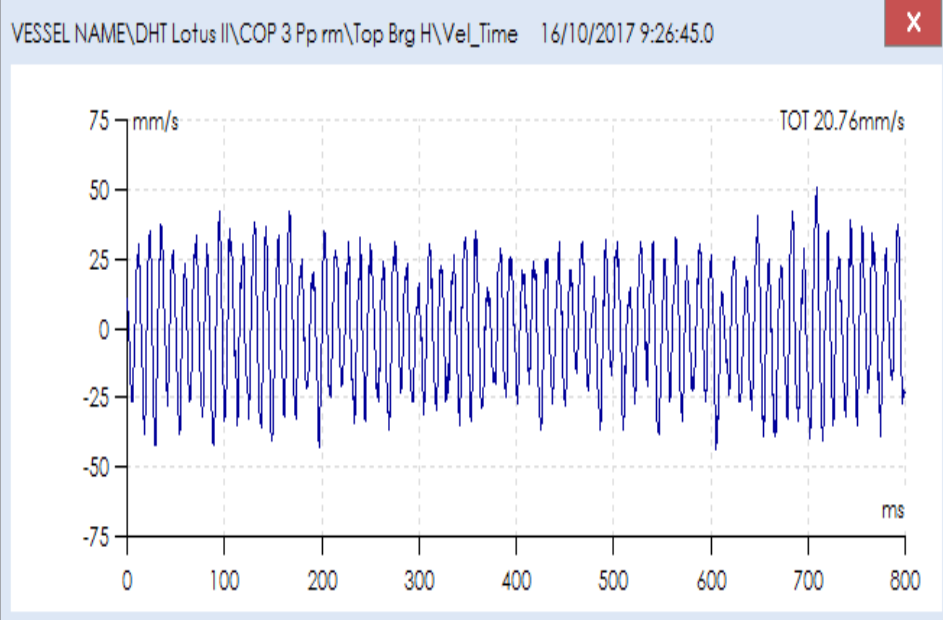
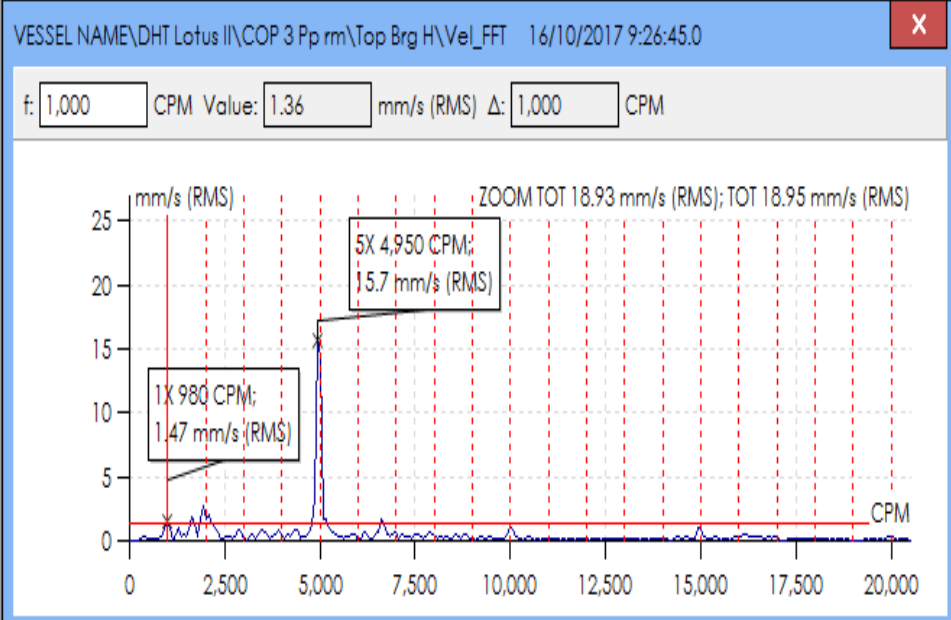
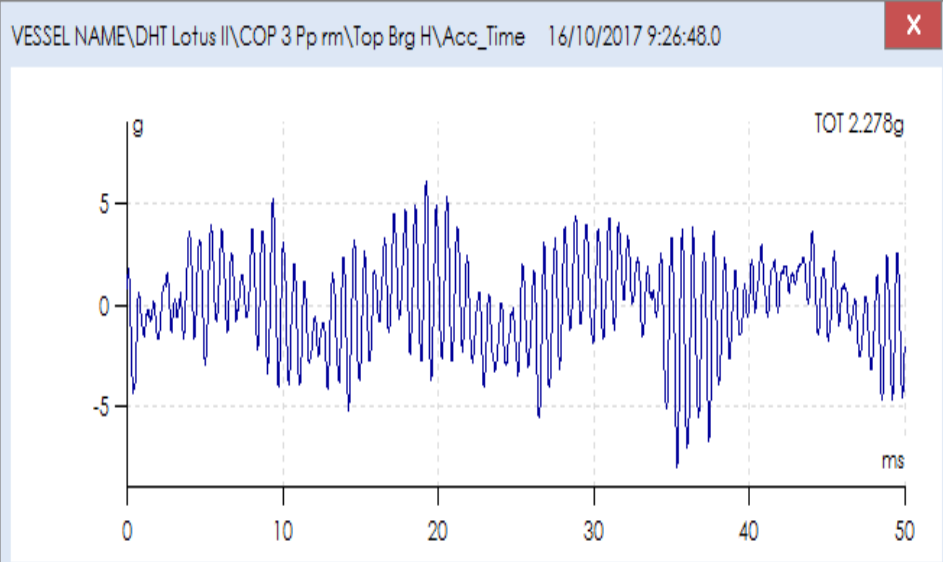
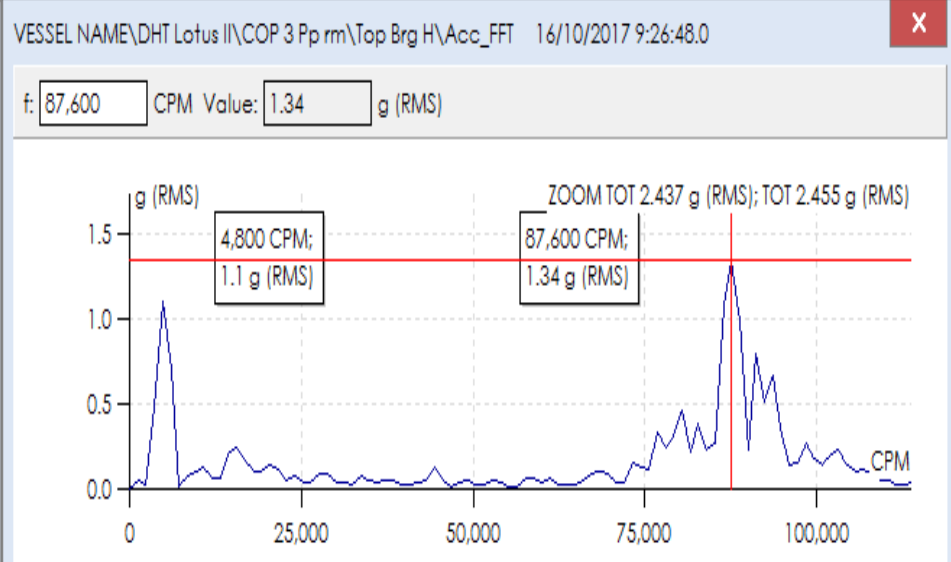
Time wave form - sample of random vibration

FFT spectrum of above wave form

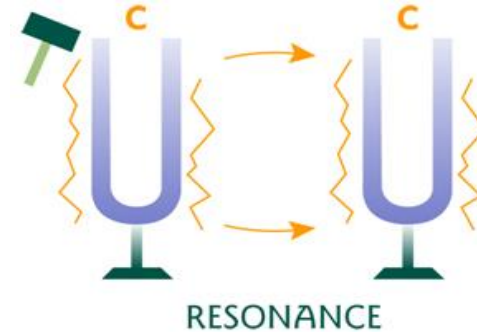
Resonance

- Resonance occurs in a system when the frequency of a vibratory force (forcing frequency) is at or near a natural frequency.
- Vibration levels at resonance are controlled through damping. Vibration amplification is determined by the proximity of the forcing frequency to natural frequency.
- When high vibration is noted in rotating machinery, the analyst should conduct a thorough vibration analysis before applying commonly used resonance fixes. After all, excessive vibration could result from one or a combination of the following non-resonance situations:
 1. pedestals, foundations, or structures
 2. loose or missing bolts, broken welds, soft foot, or
 3. mismatched parts excessive vibratory force
 4. lack of damping.

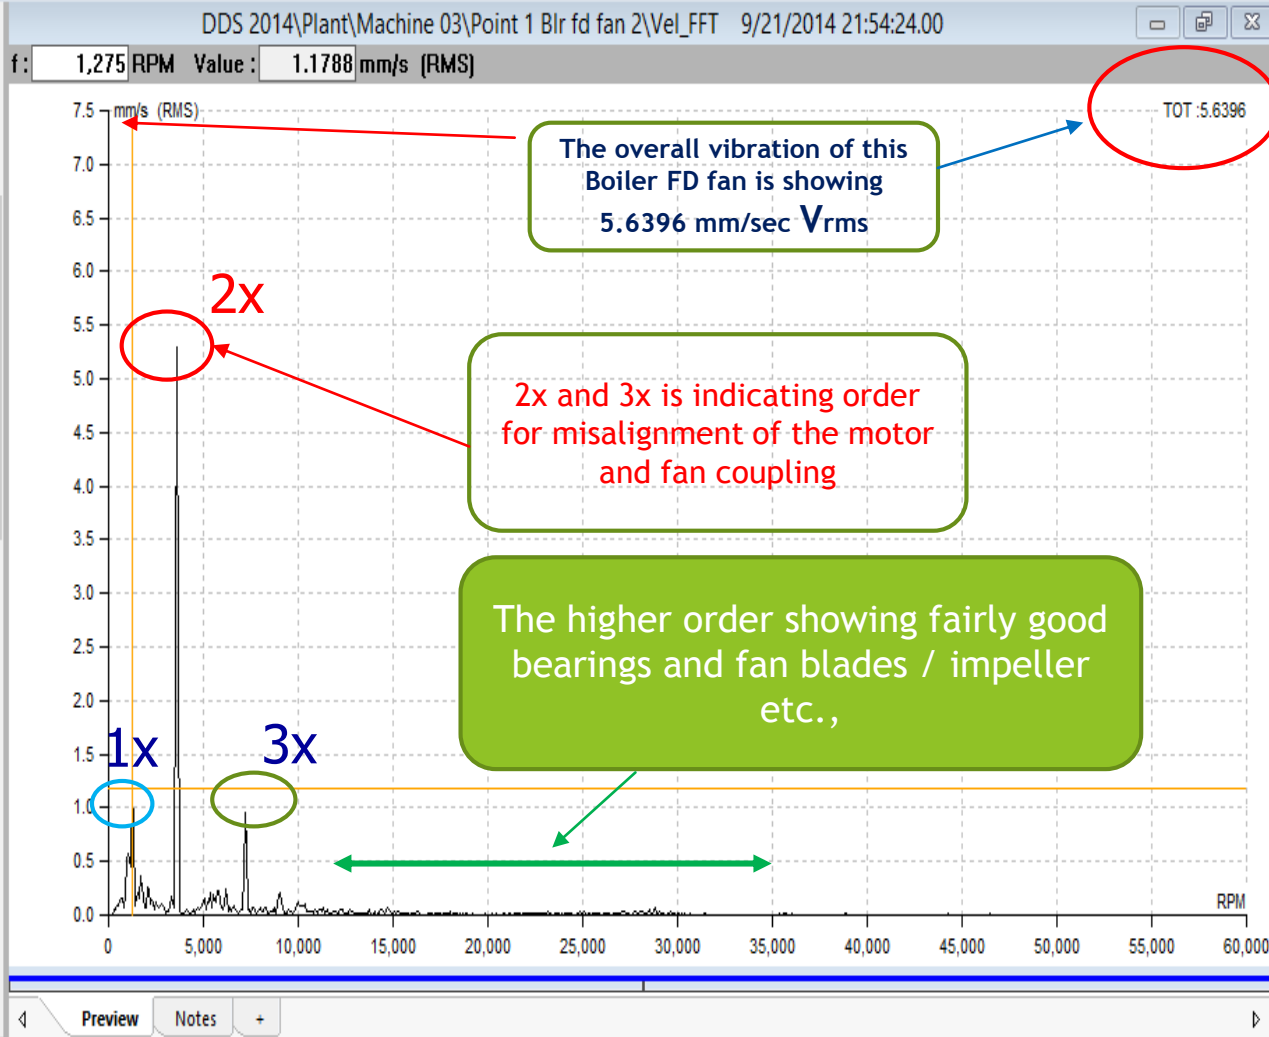
VIBRATION ANALYSIS CHART

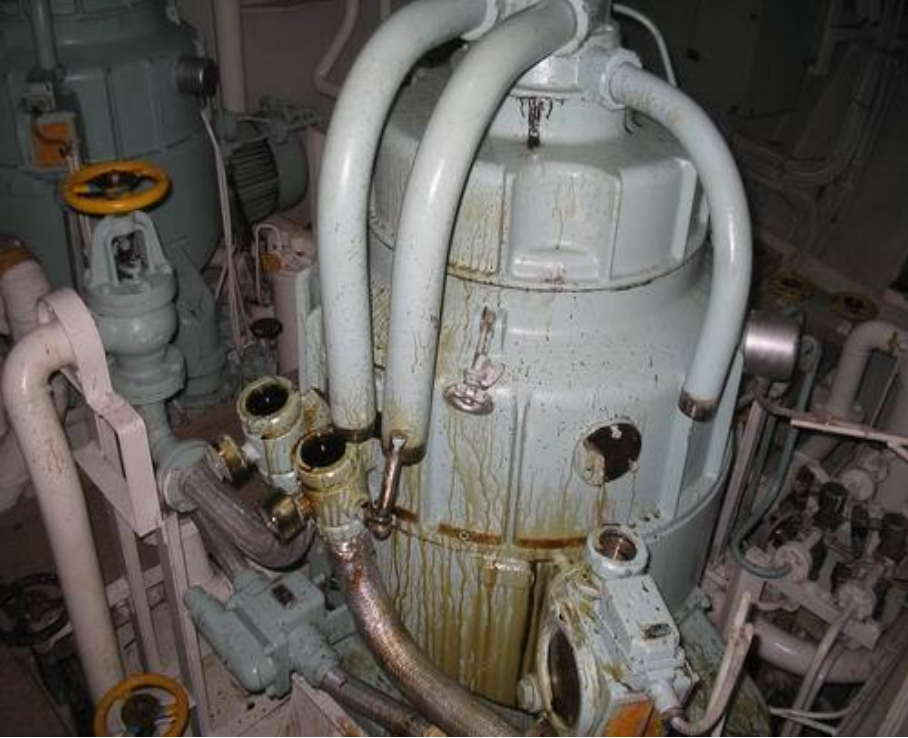
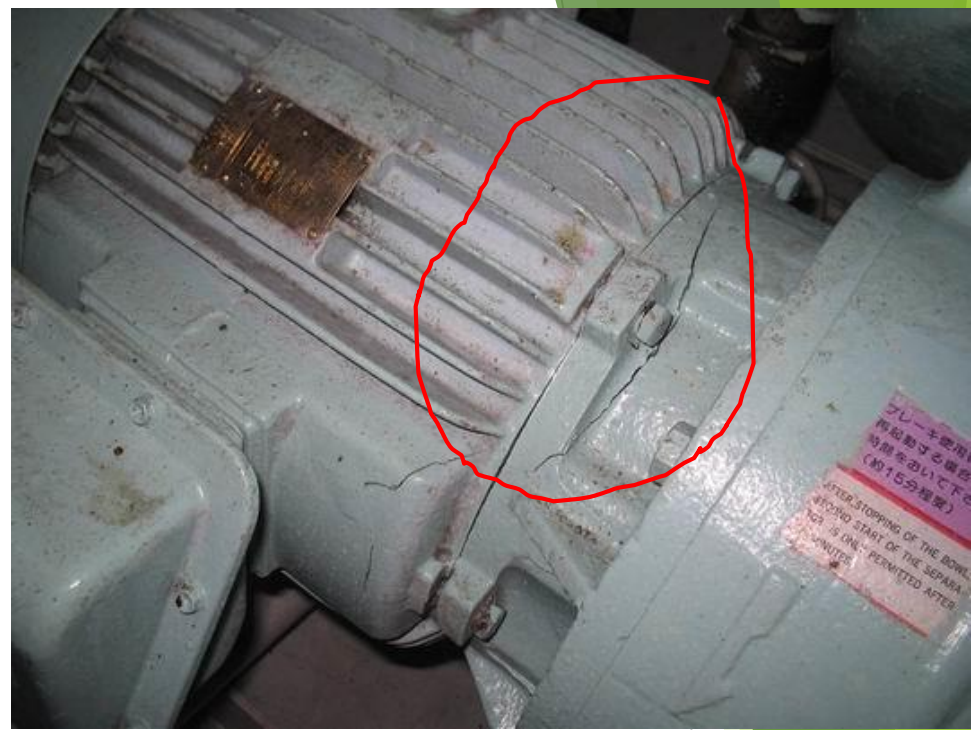
WHEN Resonance and Unbalance occur together with change in revolutions can cause serious damages

1:20:00 add
Unbalance

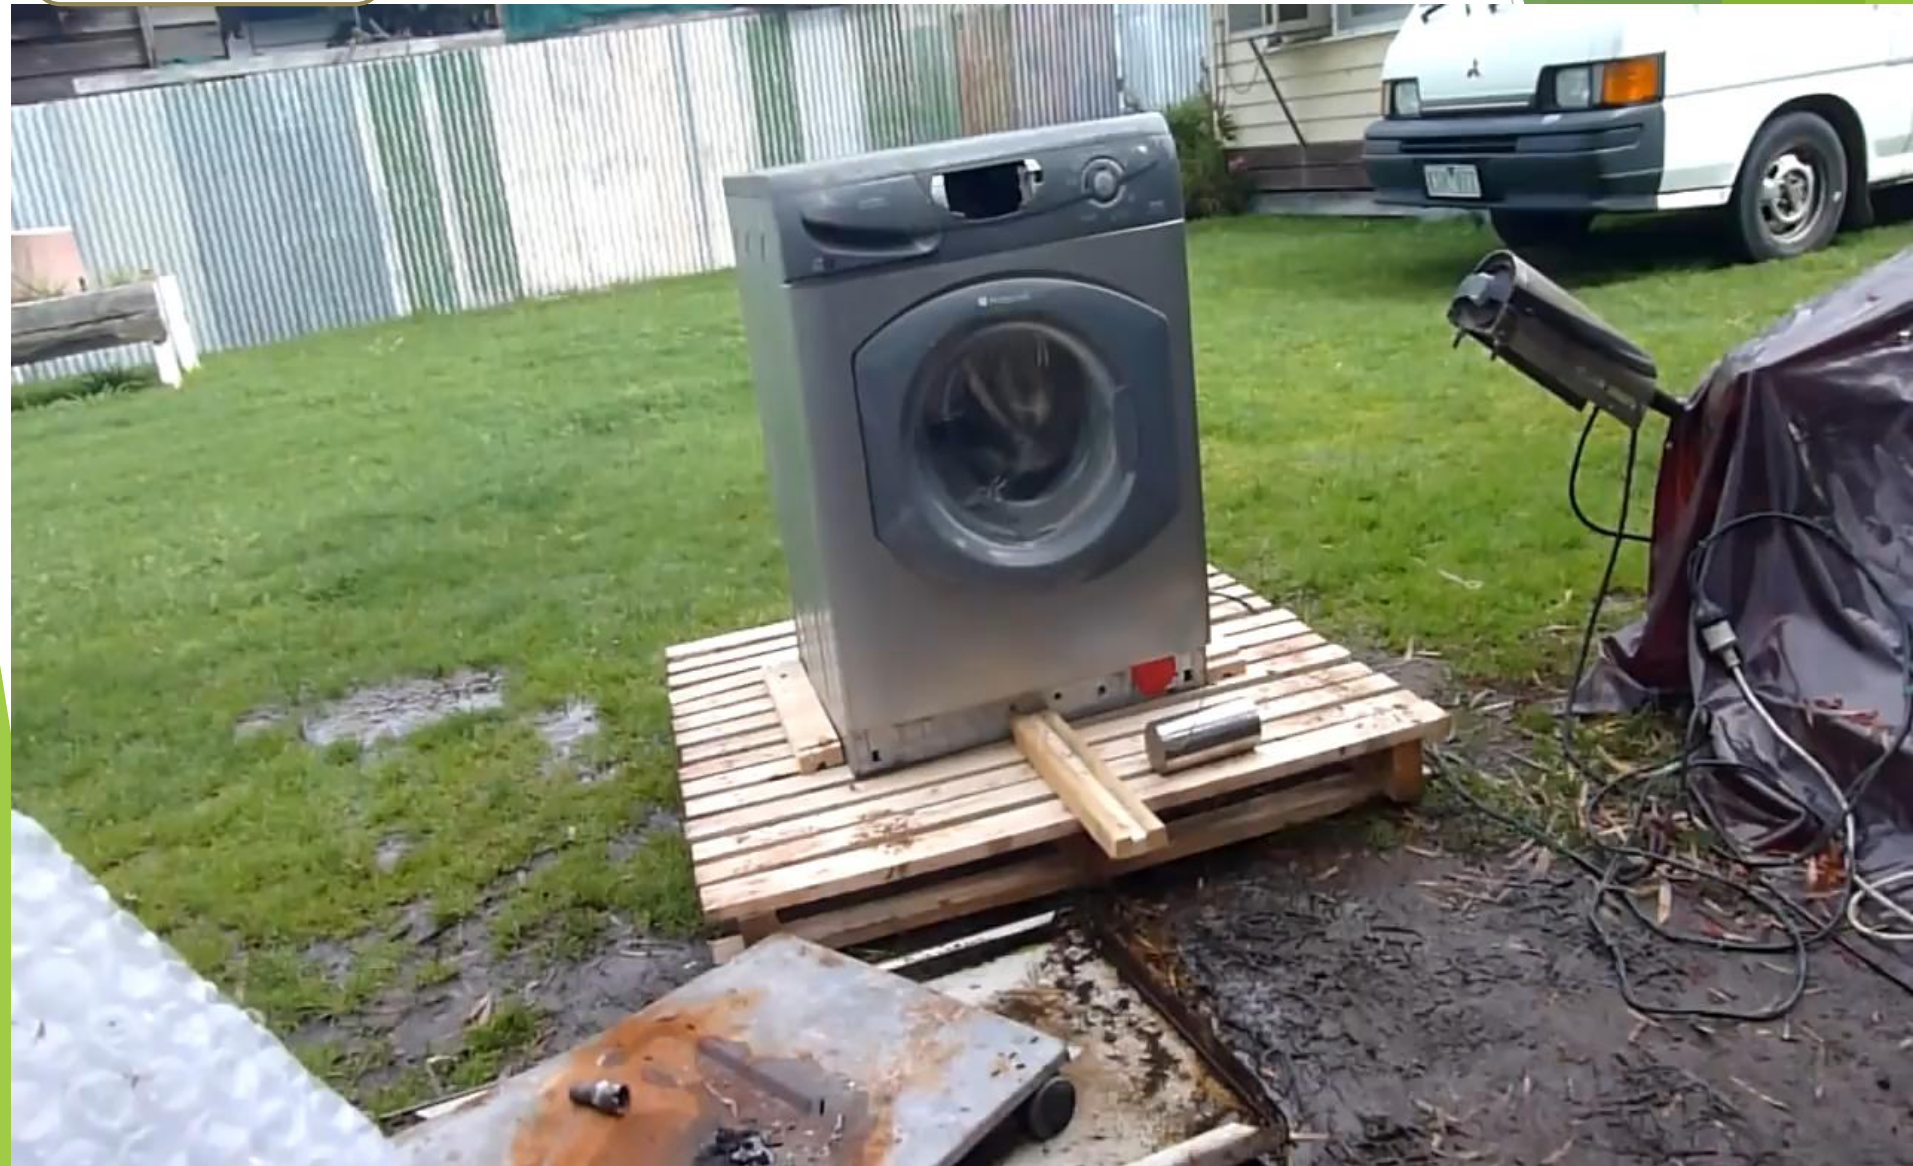
MOTOR DE vibrations recorded as following-

1. Vertical - **8.953** mm/s RMS
 2. Horizontal- **14.81** mm/s RMS
 3. Axial- **7.2** mm/s RMS.
- IACS limit for the Horizontal IG Motor is 7.0 mm/s RMS

1. Vertical - **10.75** mm/s RMS
2. Horizontal- **21.17**mm/s RMS
3. Axial- 4.208 mm/s RMS.

IACS limit for horizontal IG fan is 7.0 mm/s RMS

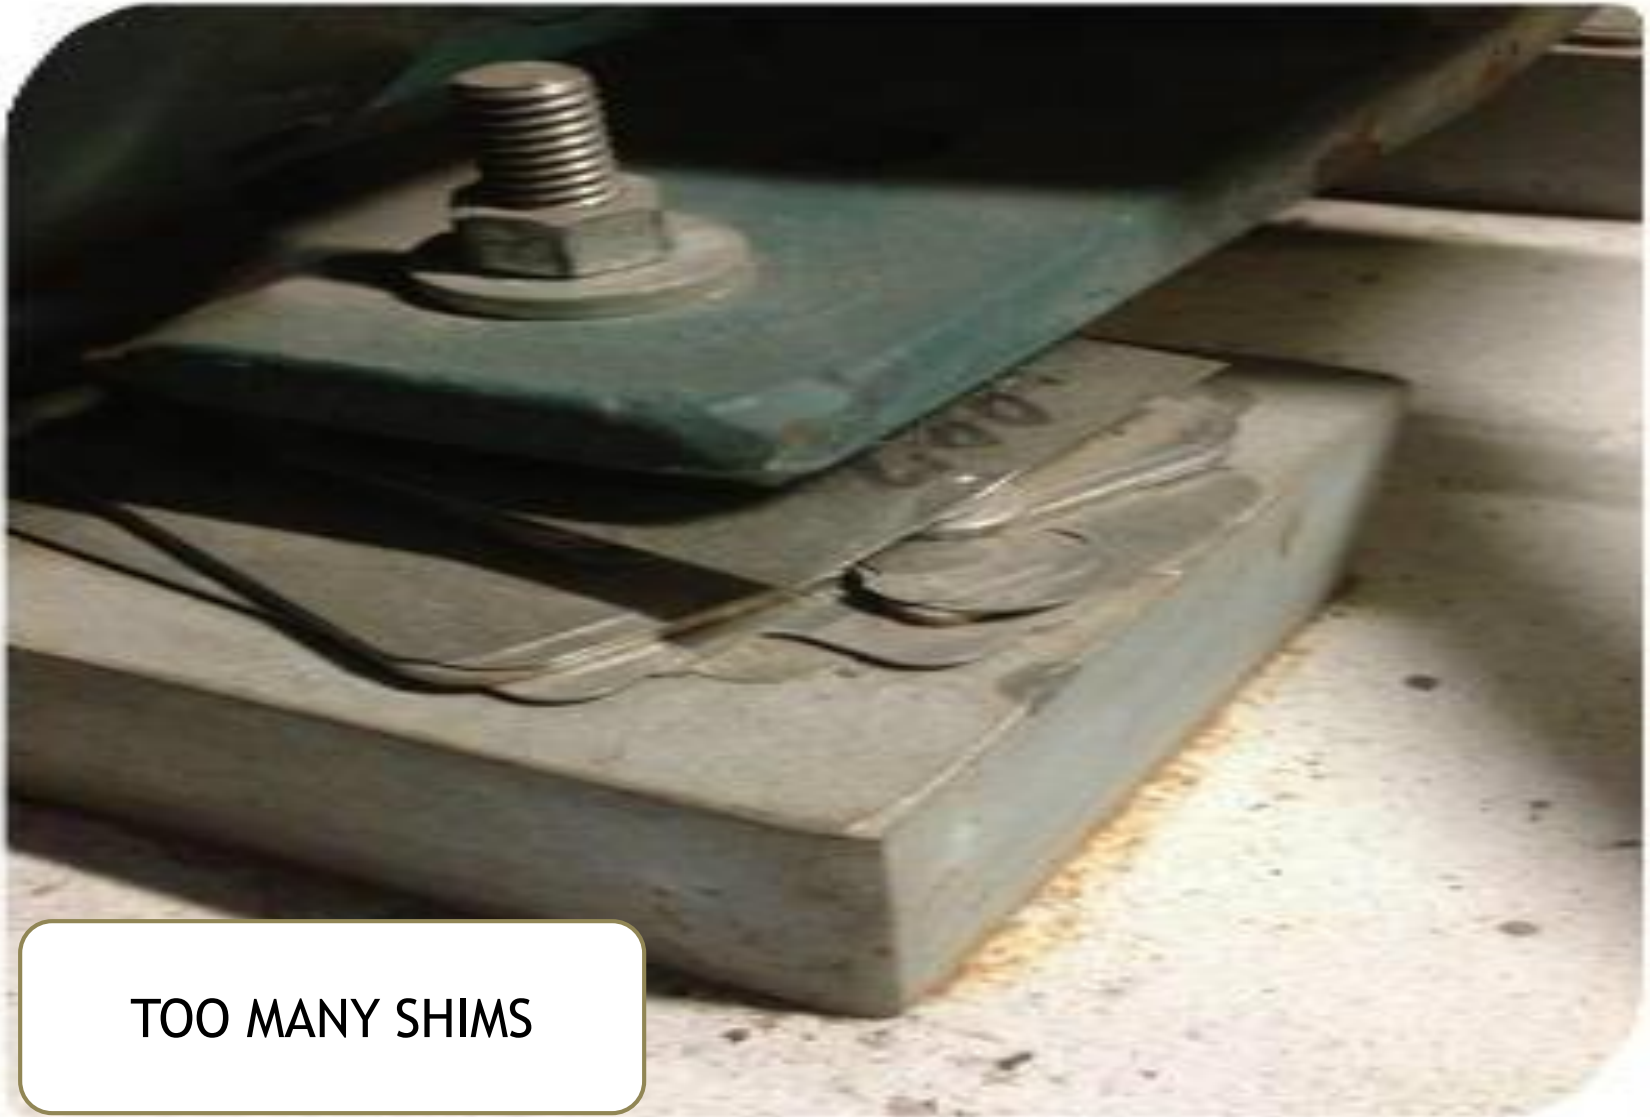
TOO MANY SHIMS

High Vibrations caused by Misalignment
case studies

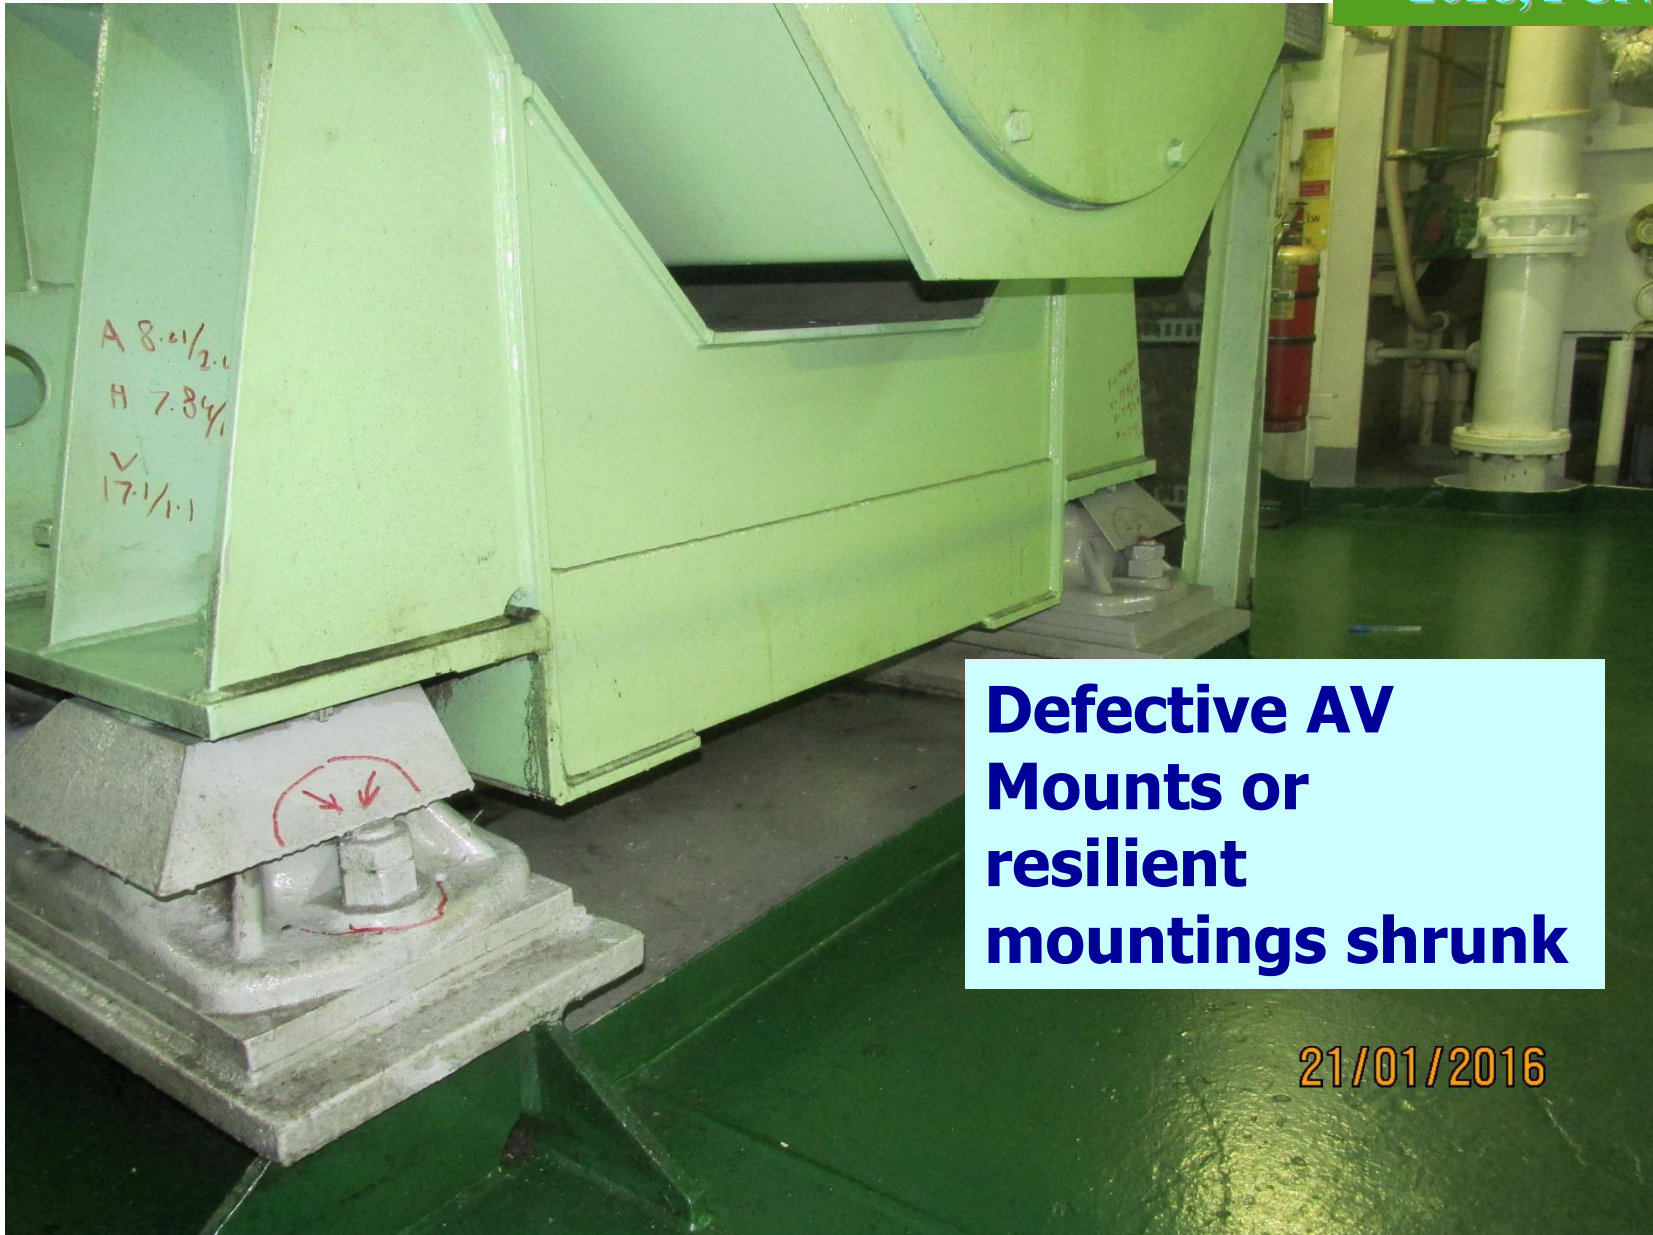
**Defective AV
Mounts or
resilient
mountings shrunk**

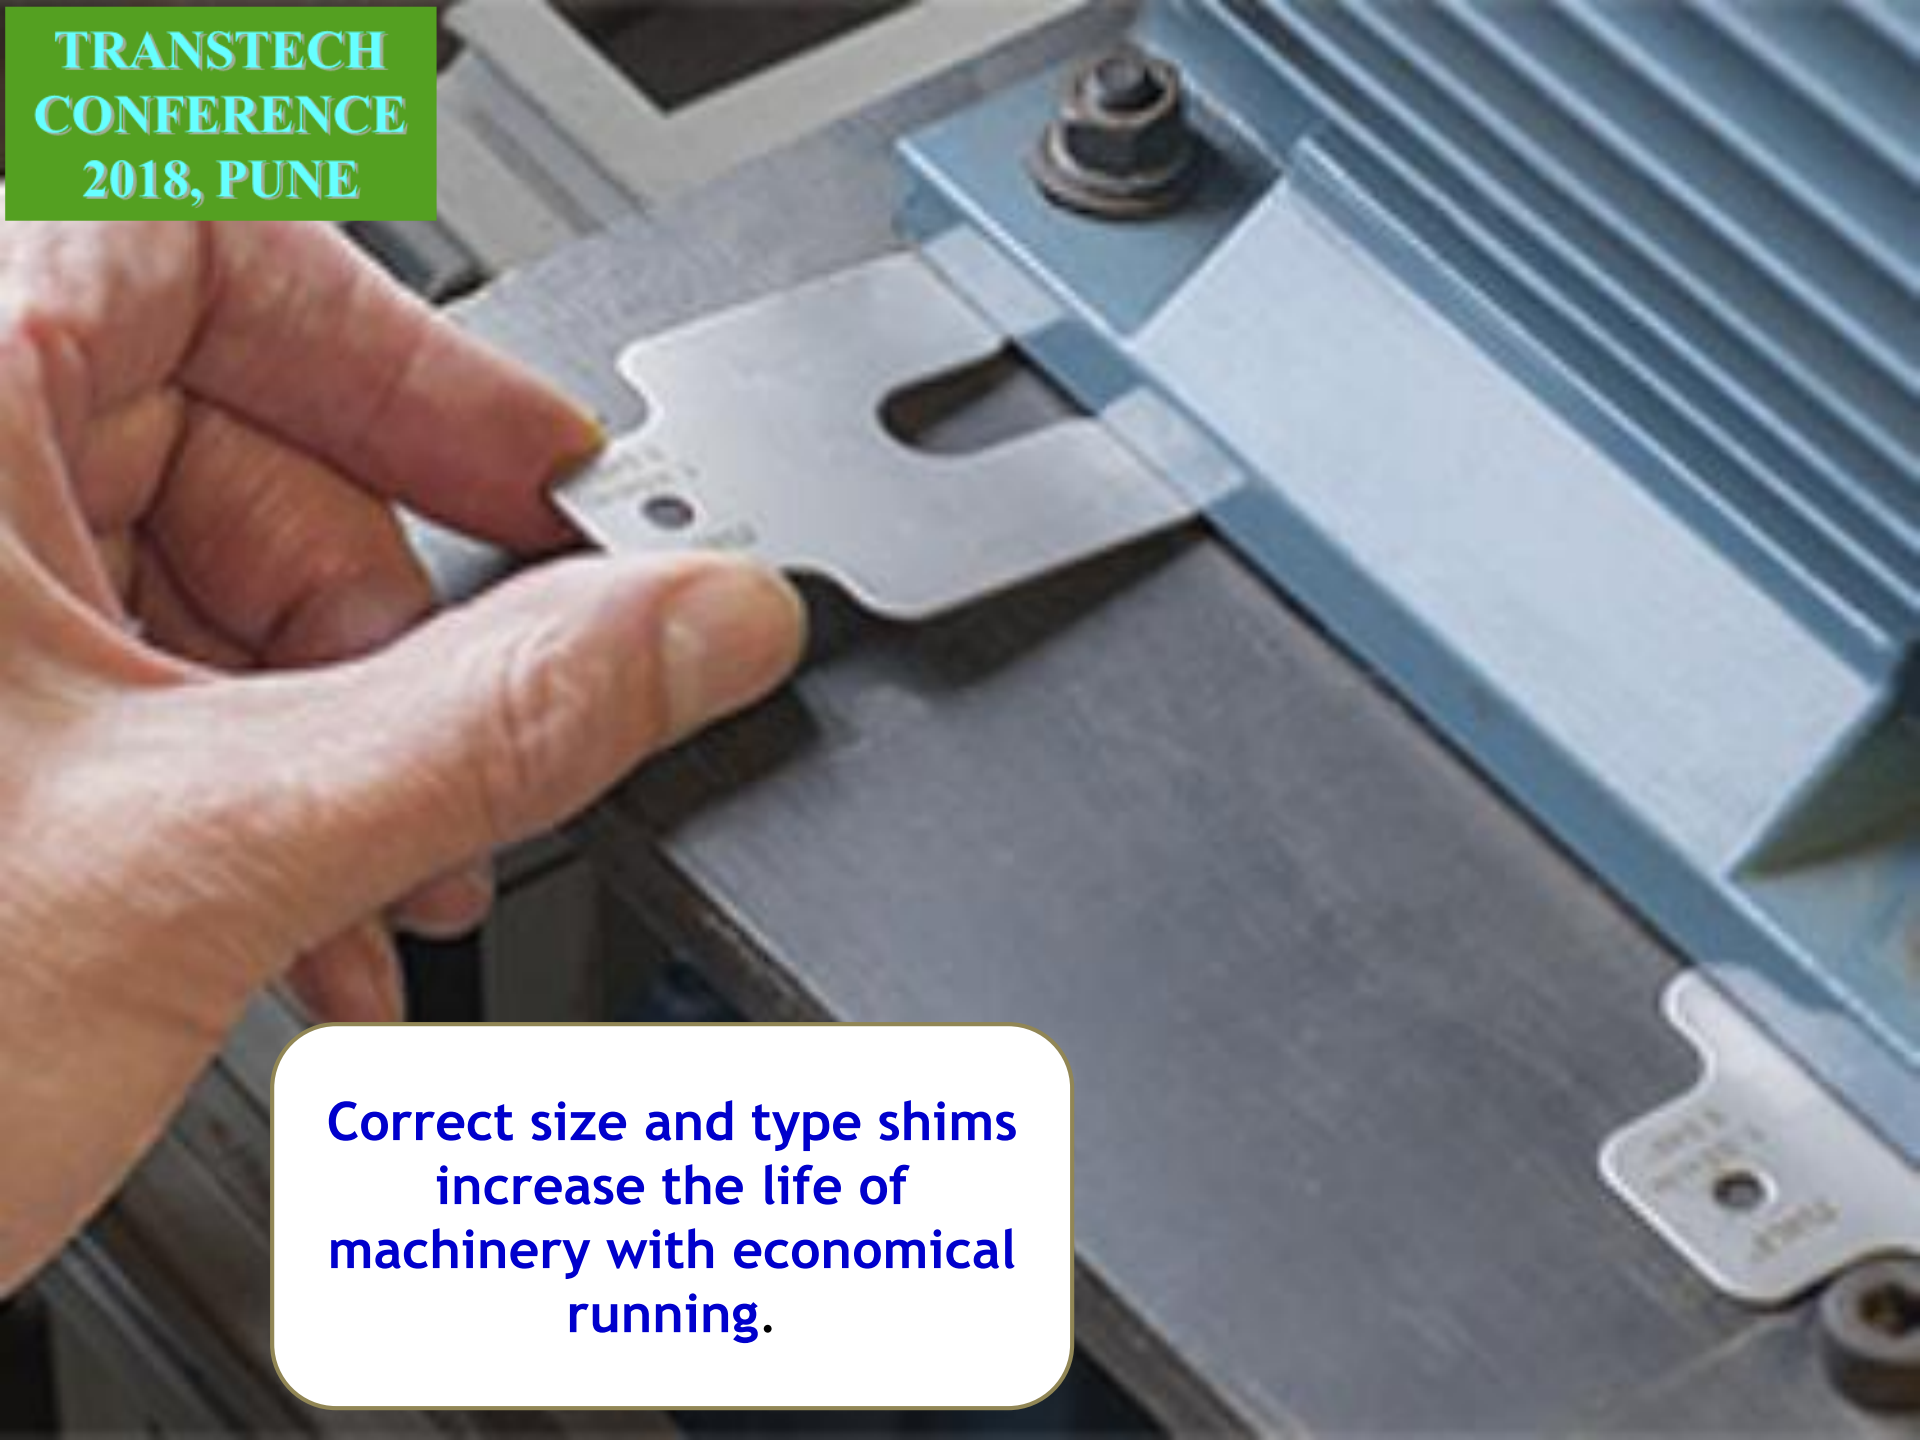
DEFECTIVE SHIMS

A close-up photograph showing a person's hand holding a thin, custom-shaped metal shim. The shim is being held in front of a piece of industrial machinery, which has a blue-painted metal housing and a dark grey base. The shim has a complex shape with a central cutout and a small hole. The background is slightly blurred, focusing attention on the hand and the shim.

**Correct size and type shims
increase the life of
machinery with economical
running.**

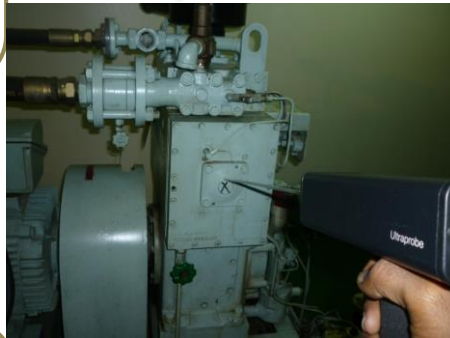
**GOOD
COMPRESSOR
VALVE**

AIR/ GAS Compressor Valve Good n Bad

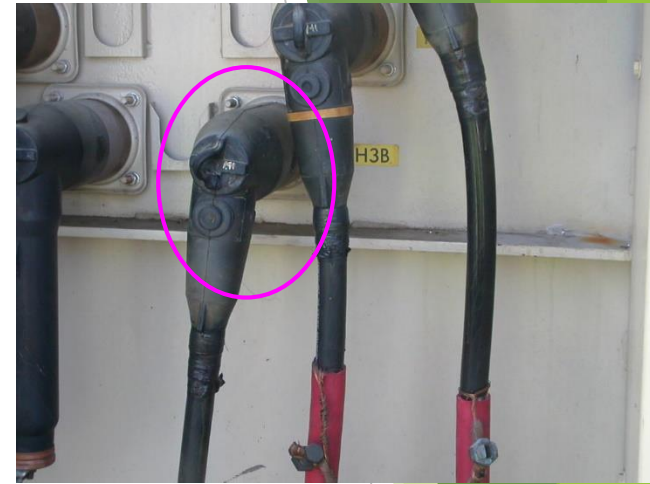
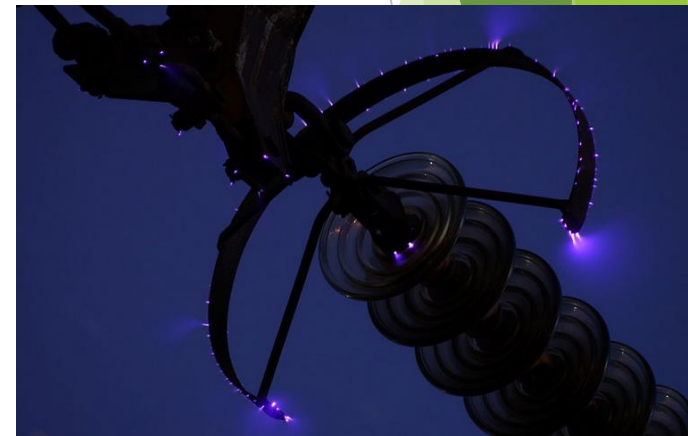
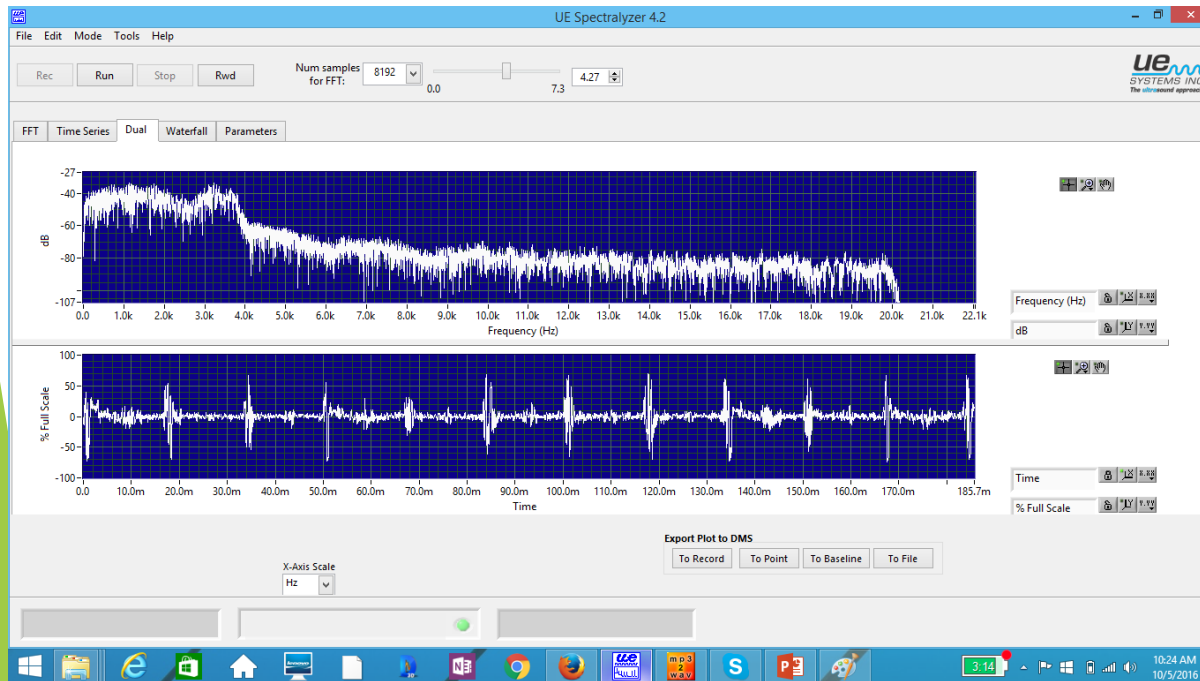
High Voltage PD condition Corona

Only occurs at 1000V and above voltage.

This is a partial discharge(Leakage) activity.

Corona: An electric discharge around conductors when the surrounding air is stressed beyond its ionization point without developing flashover.

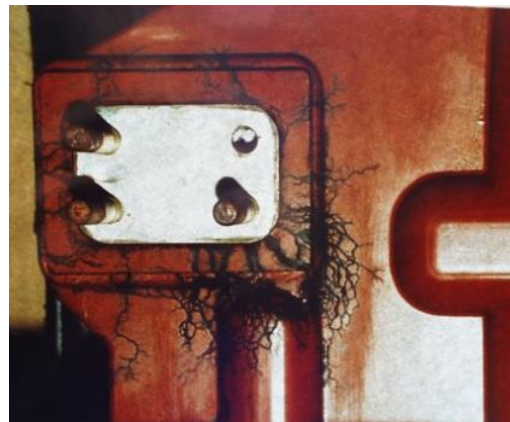
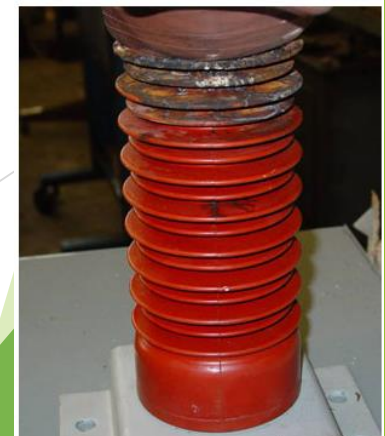
TRACKING

- Tracking occurs where there is a low current pathway to ground across an insulator.
- There is a build up and discharge of the voltage that produces “popping” sounds.
- The discharge peaks correspond to the “popping” sounds.
- They are not uniformly spaced in time.

Tracking: Electricity follows a pathway to ground utilizing dirt and other contaminants until it reaches

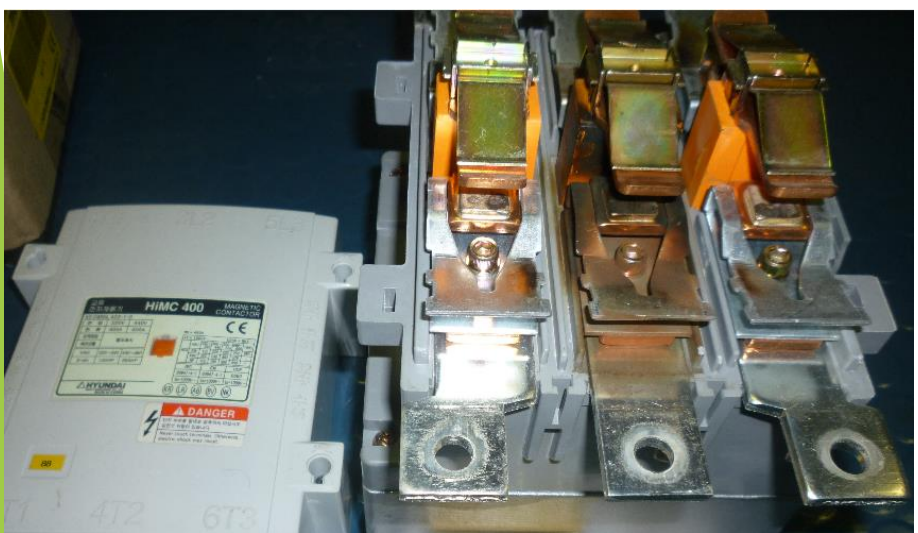
ARCING

Arc Flash Conditions

Arcing: An electric discharge through normally non-conductive media such as air. It is a failure condition in electric equipment and can lead to fire or an explosion.

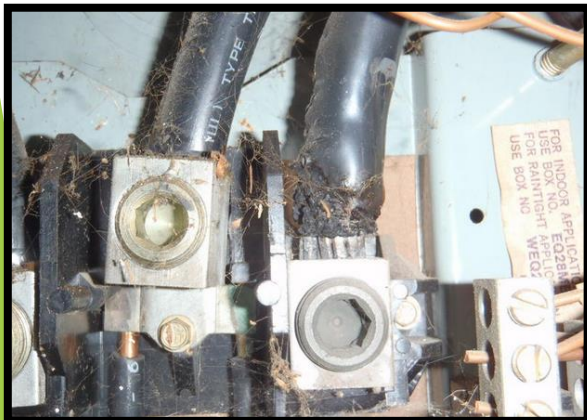
BAD AND SEVERE TRACKING OF THE ELECTRICAL INSULATION

High Voltage Components are well enclosed, making for poor or sometimes impossible infrared inspection

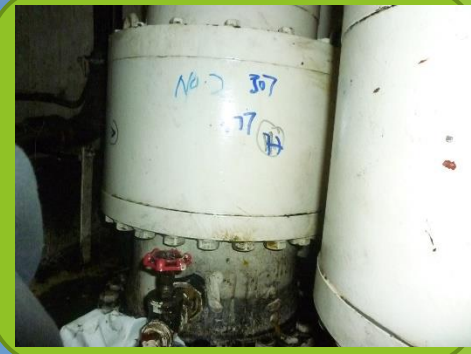
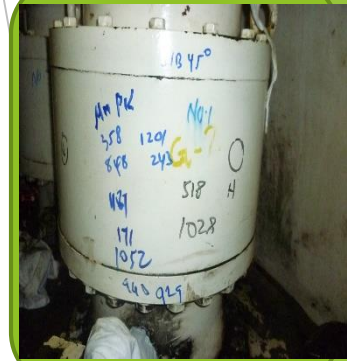
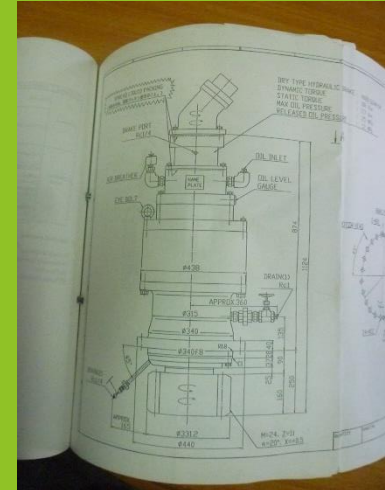
One of the ship crane
slewing operation
defect identified in
slewing motor counter
balance valves

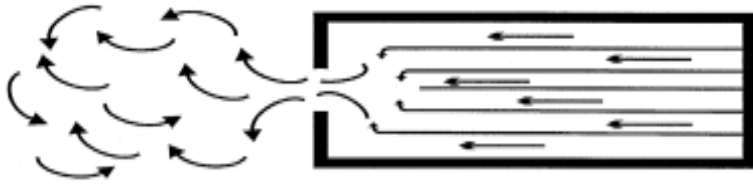
Figure 2 Pressure leak

During a pressure leak, fluid escapes and produces a turbulent flow with strong ultrasonic components. Ultrasound is localized to the point of emission, making the leak readily detectable.
