INTEGRATED CONDITION MONITORING TECHNOLOGIES FOR ENERGY SAVING APPLICATIONS

TRANSTECH
CONFERENCE
2018, PUNE

GREEN SAILS SINGAPORE CONDITION MONITORING TECHNOLOGIES FOR MARINE, OFFSHORE AND INDUSTRY

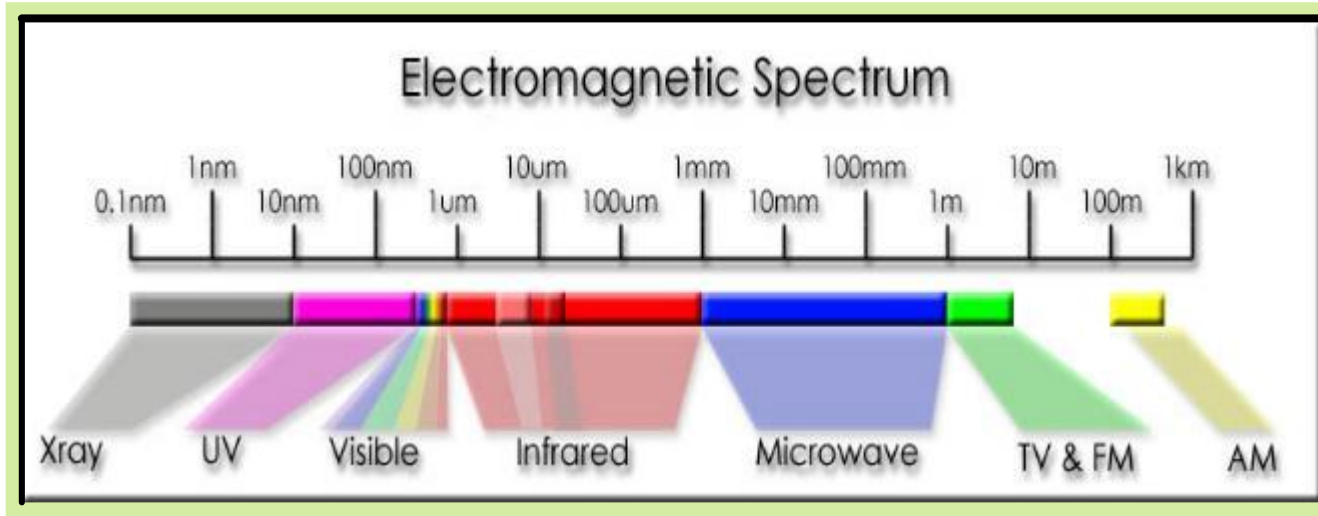
What is Infrared?

- ☛ Infrared is a form of electromagnetic radiation
- ☛ Everything above -273°C (absolute zero) emits infrared radiation
- ☛ The heat we feel from the sun is infrared energy

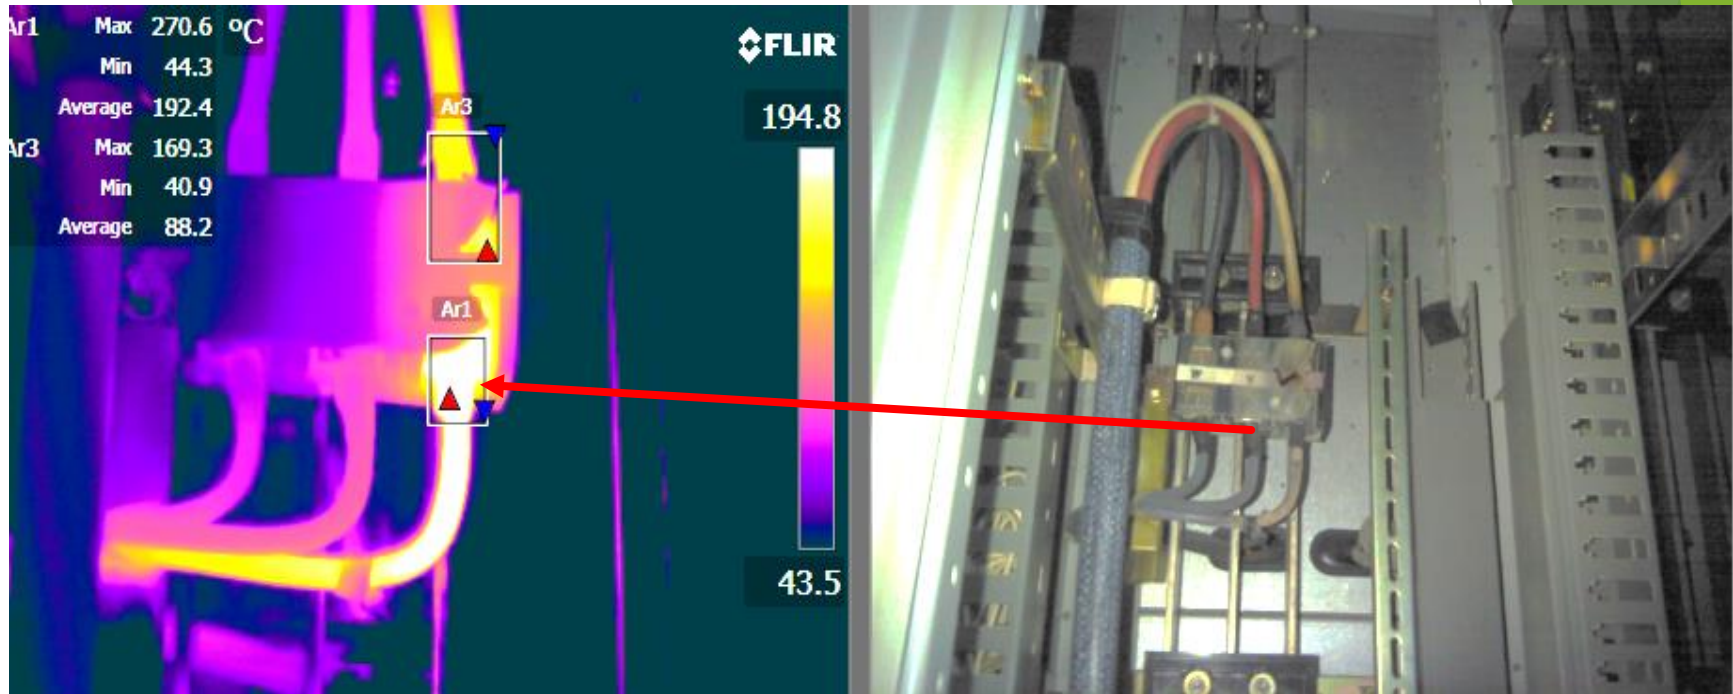
This could be catastrophic failure on a VLCC can cause fire in main switch board

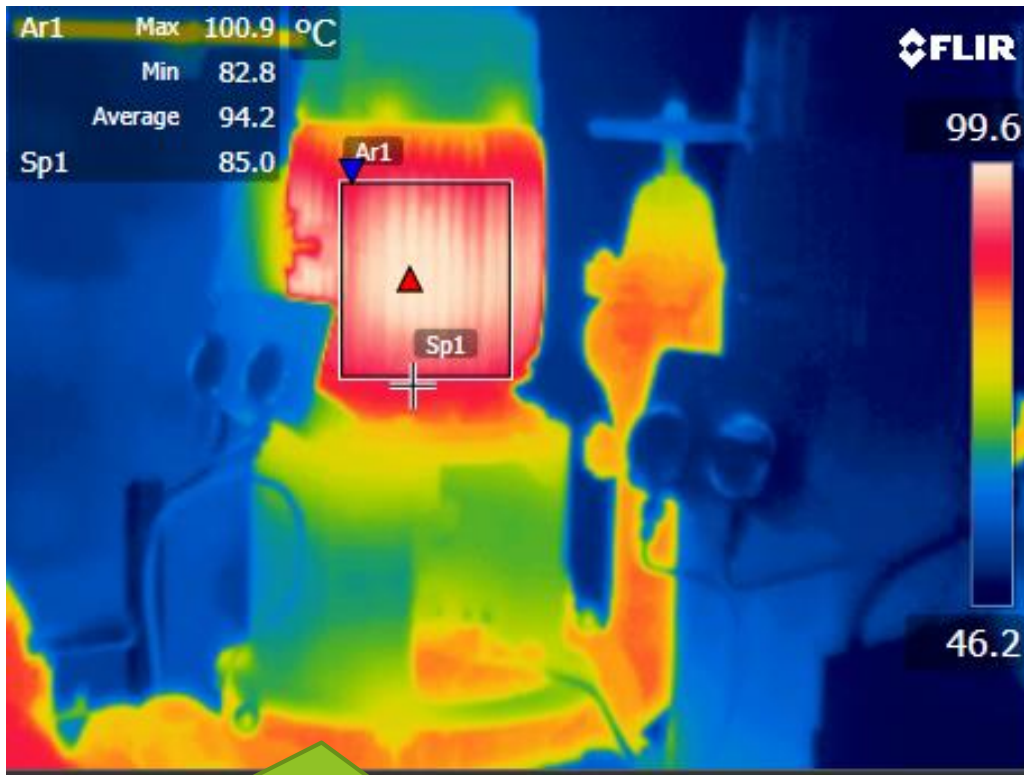
A TYPICAL MOTOR / PUMP PROBLEM - EXAMPLE

This photo is taken in a leading company tanker vessel and displaying as example.

The thermal image and related Digital image of Marine pump installation. In digital profile the pump and motor showing Good. In thermal image the motor is in trouble and drawing 10% excess amperes . The motor will burn if the action is not taken immediately.

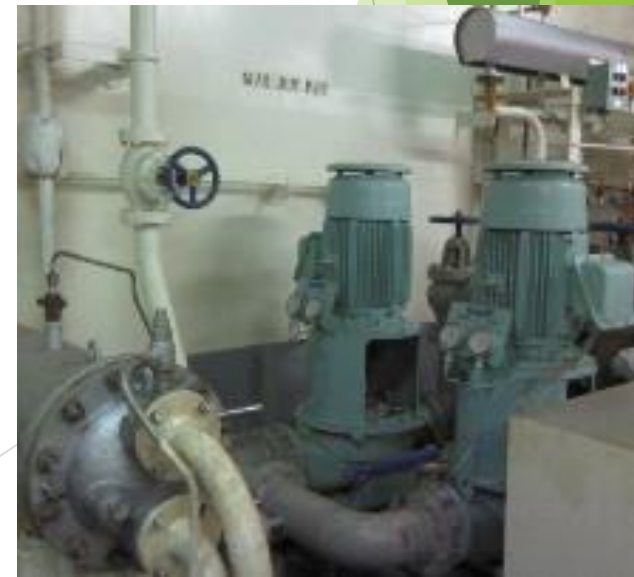
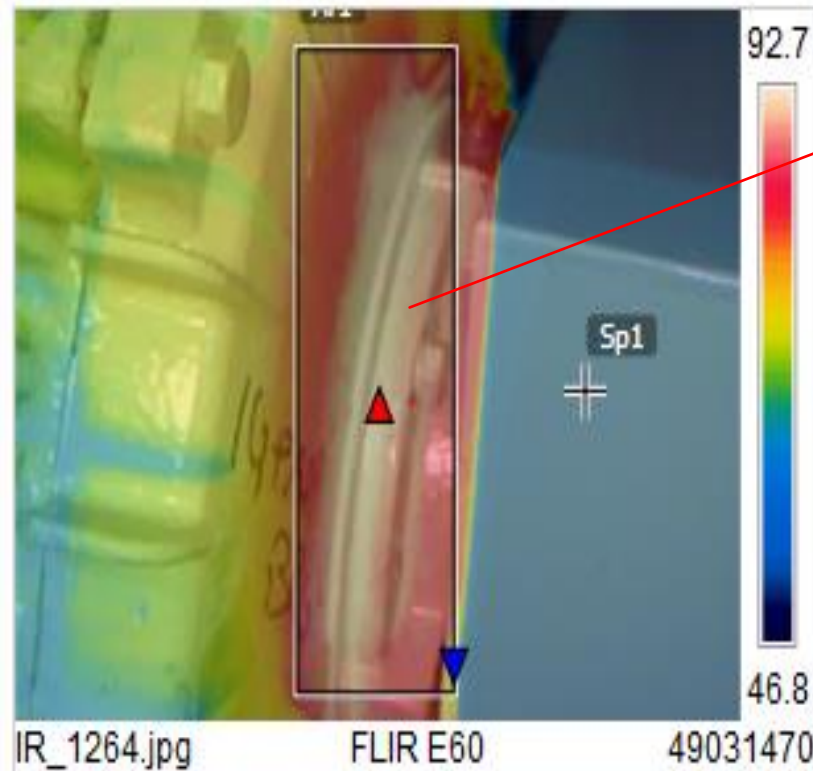
Note	
IG FAN NO1 DRIVE END BEARING

A 250 kw motor inert gas fan in a vlcc operating with drive end bearing temperature of 93.3*c is going to cause damage to motor due to misalignment and overloading

Measurements °C	
Ar1 Max	93.3
Min	72.7
Average	87.6
Sp1	52.0

Parameters	
Emissivity	0.94
Refl. temp.	35 °C

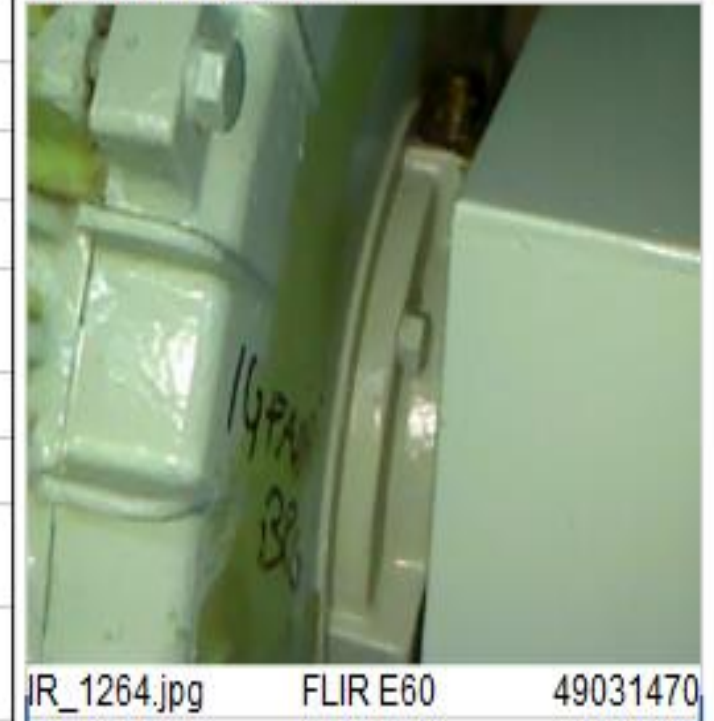
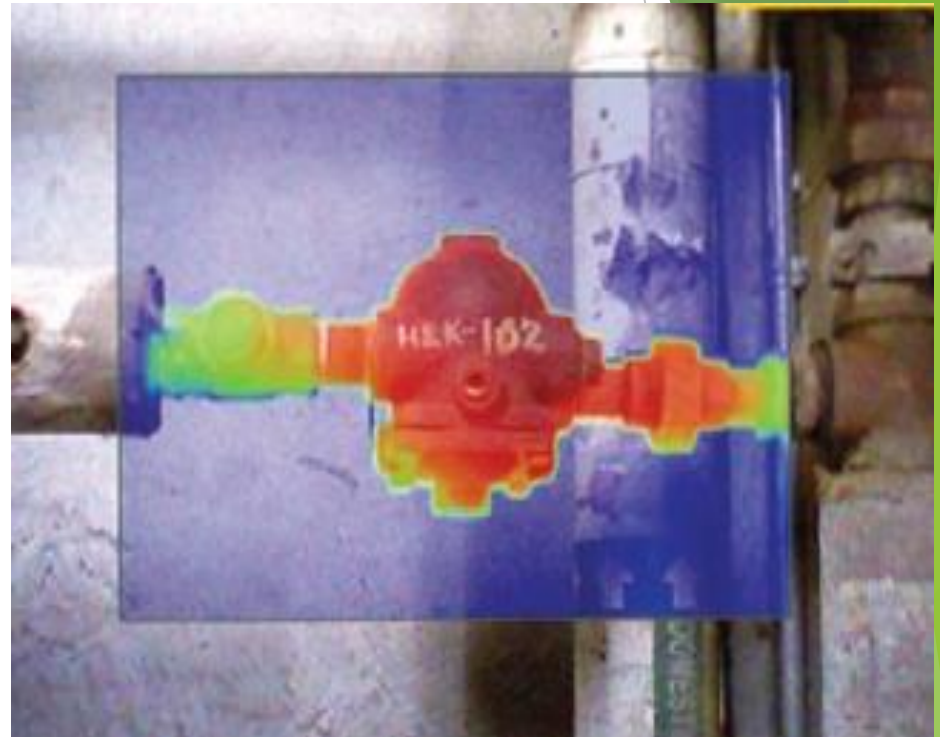
cause and effect of failed steam traps

- steam traps stuck (open) position:
 - waste of energy and damage to atmosphere condenser.(\$\$\$)
 - excess steam in system
 - create back pressure back pressure can cause other steam traps to malfunction
- steam trap stuck in shut (closed) position:
 - water hammer
 - line clog and corrode
 - possible rupture

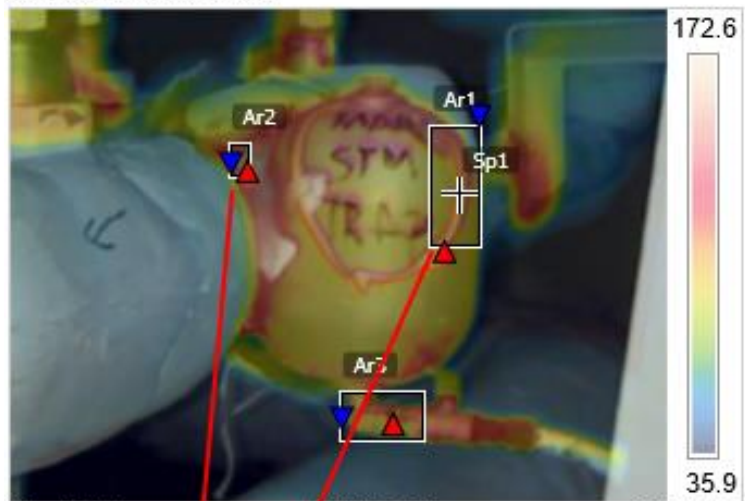
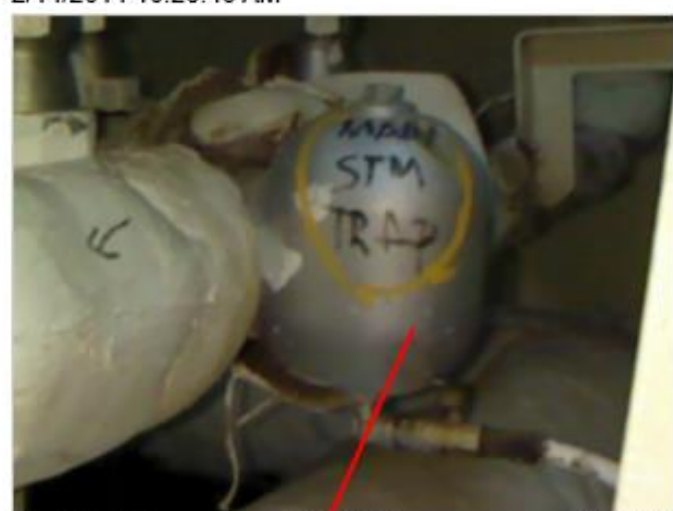
DEFECTIVE STEAM TRAP

defective steam trap

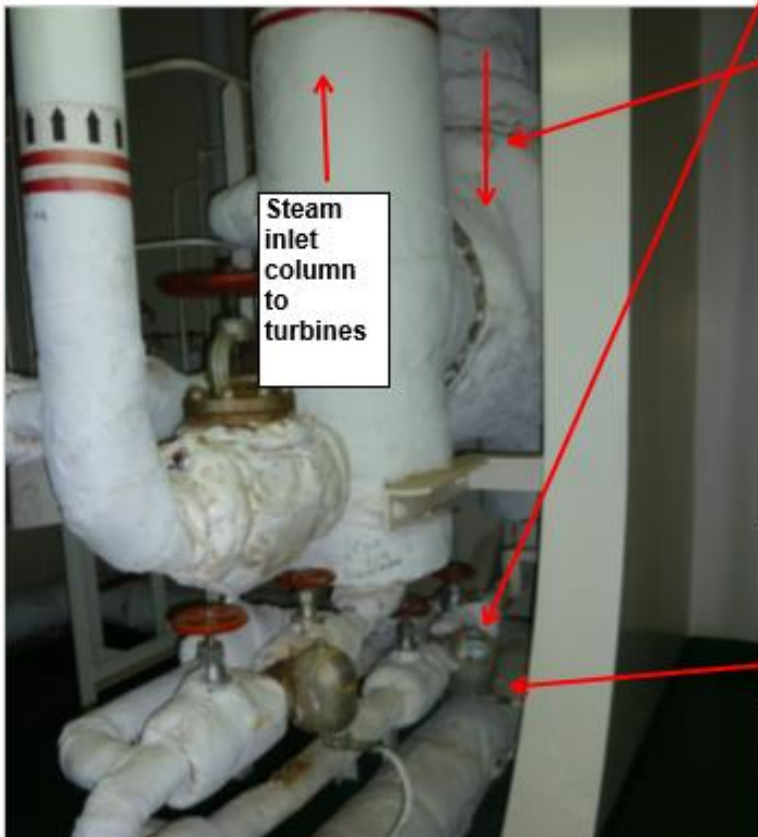
Main steam line from boiler to turbines

Steam inlet column to turbines

A sample steam trap operating onboard steam turbine plant

NOTE: THIS DEFECTIVE STEAM TRAP LOSS IS ESTIMATED ABOUT 5-10% OF LIVE STEAM LOSS BACK TO ATMOSPHERIC CONDENSER

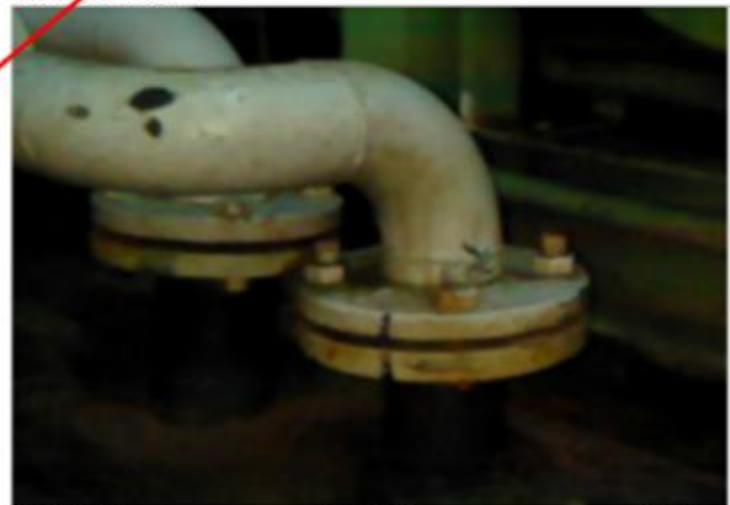
IR_7133.jpg

Measurements		
Ar1	Max	39.3
	Min	38.6
	Average	38.8
Ar2	Max	36.2
	Min	35.5
	Average	35.9
Sp1		38.8
U1	Max	32.3
	Min	31.6
	Average	32.0
Parameters		
Emissivity		0.95
Ref. temp.		20 °C
Note		
Inlet and outlet pipes of condenser

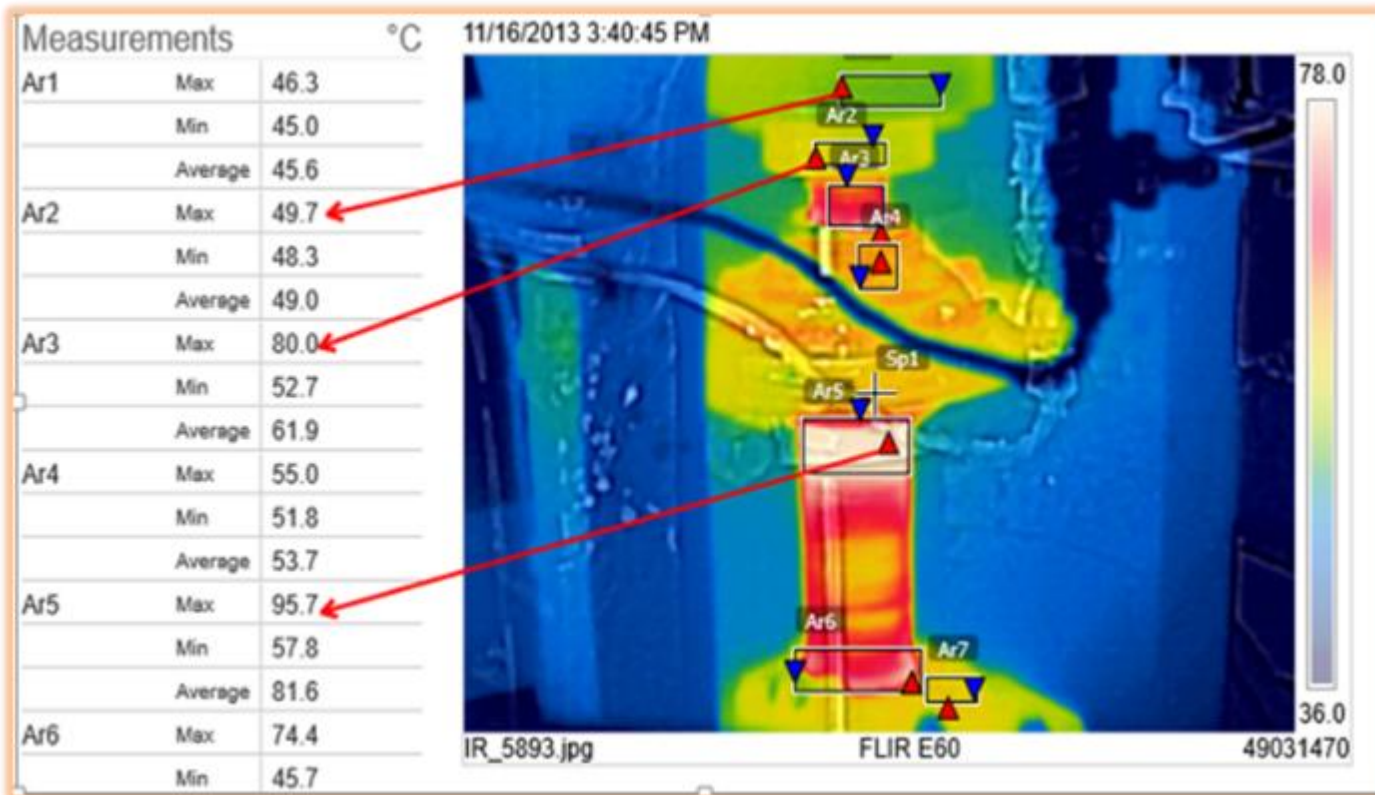
COUPLINGS AND SHAFTS ALIGNMENT

- ▶ Couplings inspection is difficult in normal operation.
- ▶ We need to understand coupling, different coupling have different thermal signatures.
- ▶ Misalignment, excessive wear are general defects are observed with infrared thermography.

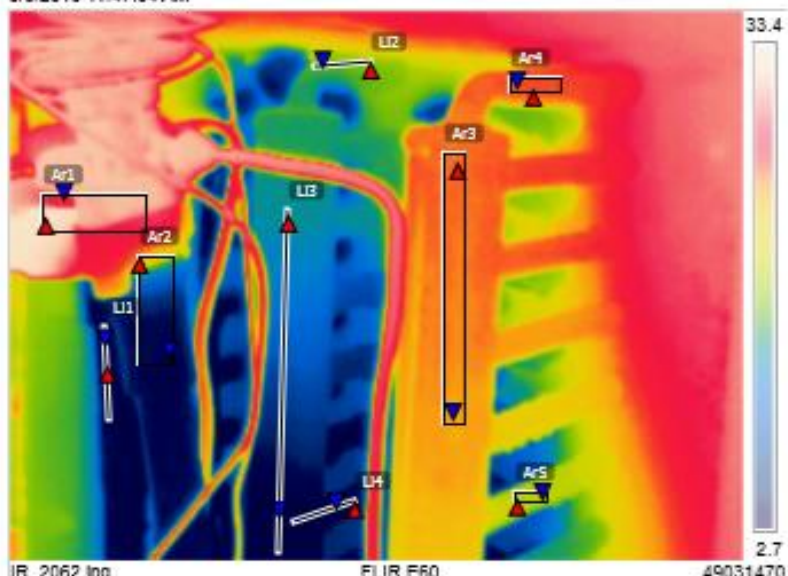
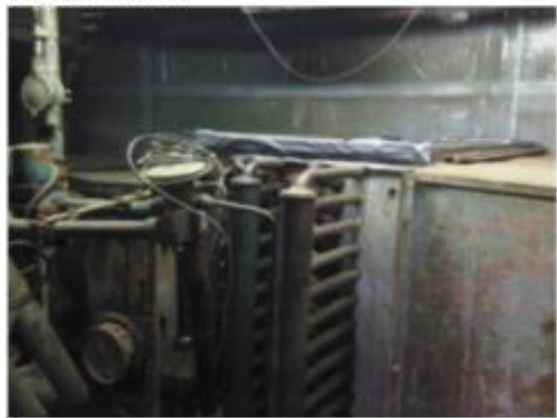
Note
AC EVAPORATOR RETURN HEADERS ANALYSIS

1. THE EVAPORATOR RETURN HEADER NO1 (IN YELLOW N RED COLOUR) SHOWING HIGH TEMPERATURE AT AR4 26.5°C HIGH AND LOW AR5 19.9°C OF THE RETURN GAS TEMP.
2. THE EVAPORATOR RETURN HEADER NO2 IN BLUE COLOUR LI3 2.8°C LOW AND 15°C IS HIGH.
3. THIS EVAPORATOR RUNNING ON TWO COMPRESSORS AND STILL UNABLE TO PERFORM THE COOLING EFFECT DUE TO PARTIALLY CHOKED AND INADEQUATE REFRIGERANT CIRCULATION.
4. THE COMPANY HAS TO RENEW THE ENTIRE EVAPORATOR UNIT DUE TO THE FLOCCULATION AND FLOW RESTRICTIONS IN THE EVAPORATOR.

Sample evaporator liquid refrigerant inlet and expanded gas outlet at the return headers for each coil

Both above compressors connected to this defective evaporator coils. Loss of energy with 2 compressors running with minimum climate control effect

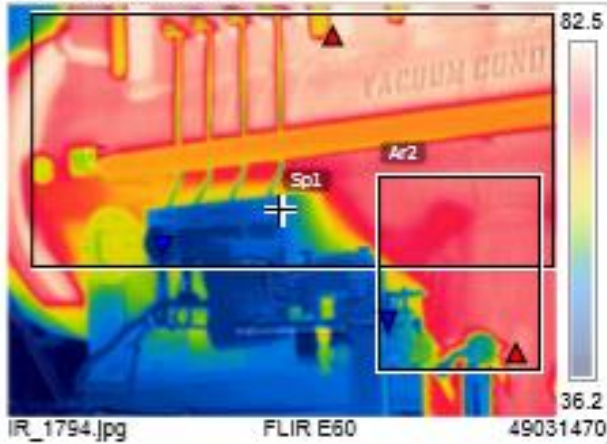
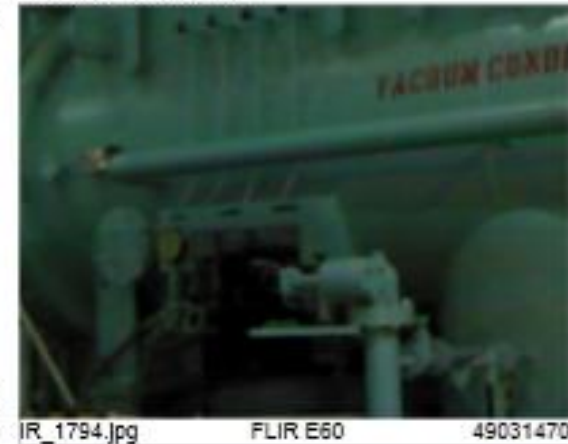
A vacuum condenser operating at high temperature loss of vacuum and burning more fuel for additional steam demand causing losses of energy

1. THIS IS A VACUUM CONDENSER IN A TURBINE PLANT OPERATING MORE THAN DESIGNED TEMPERATURE.
2. THIS HIGH TEMPERATURE OPERATIONN CAUSE8 LOSS OF VACUUM, LOSS OF STEAM ENERGY UTILIZATION, CONSUMING MORE FUEL INCREASE STEAM CONSUMPTION, MORE POLLUTION ETC..
3. THIS CONDENSER MAXIMUM TEMP OPERATION DESIGNED TO 86°C BUT OPERATING ABOUT 82.8°C.

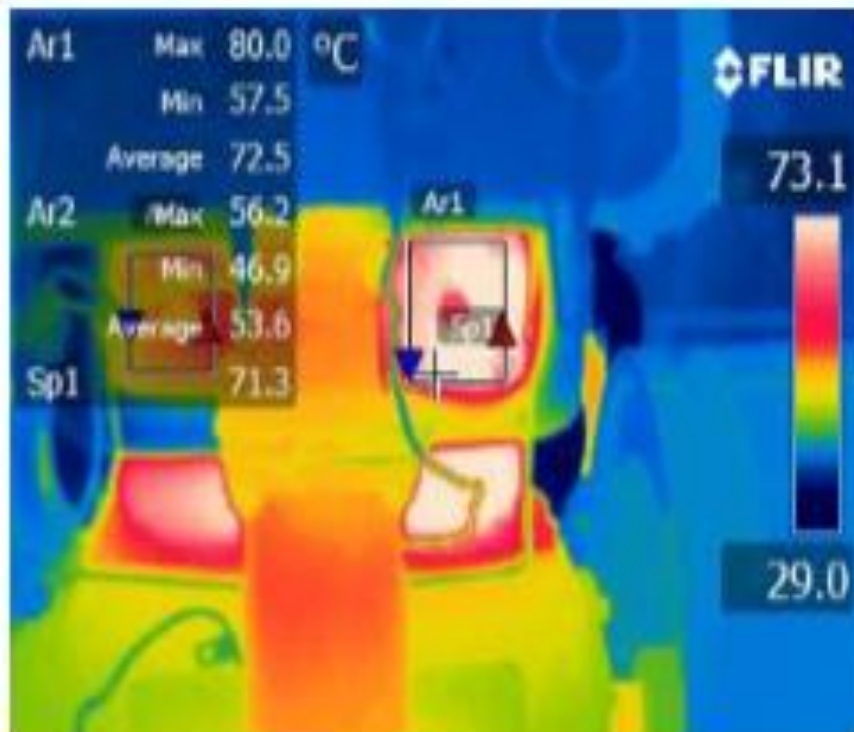
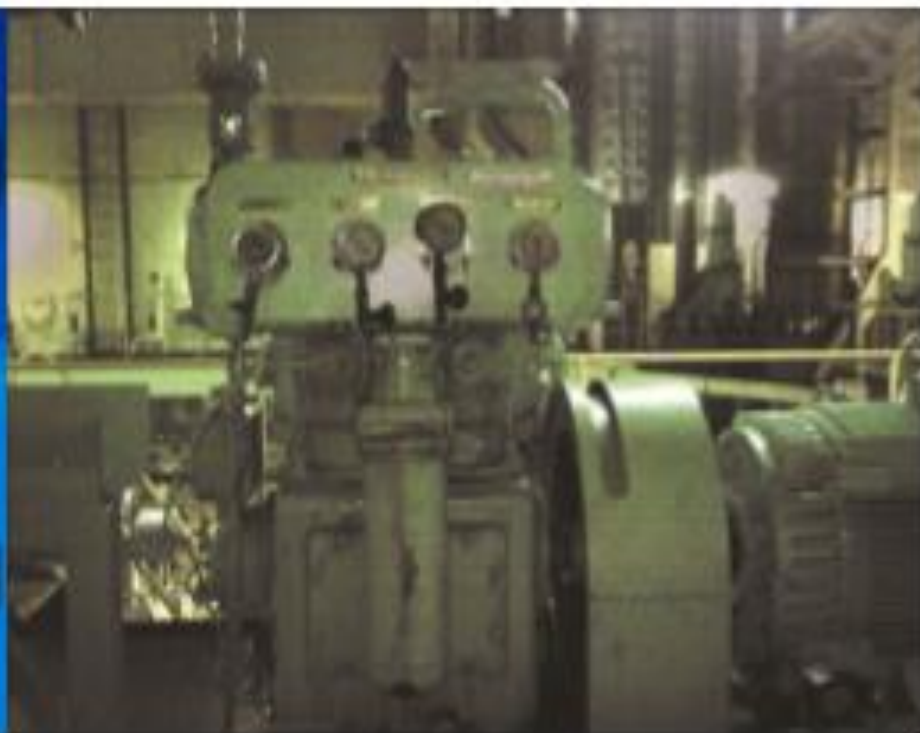
Marine Propulsion Gear box showing high bearing temperatures

The Gear box drive end bearing showing 85.4°C where the Lube oil temperature at the cooler inlet 48°C indicating trouble at the bearing condition.

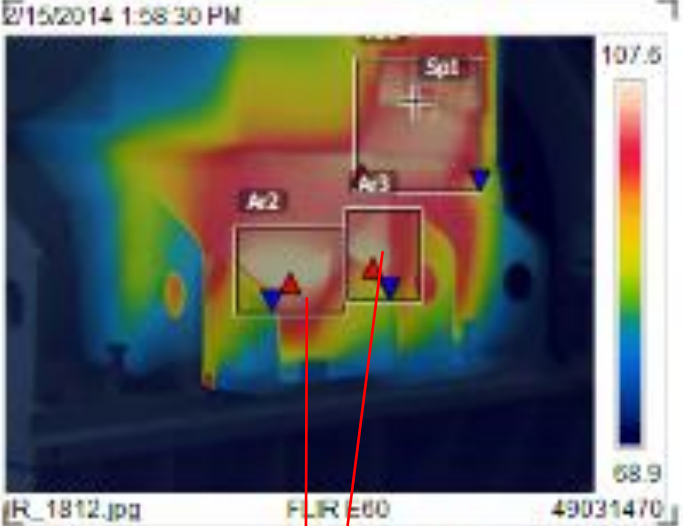
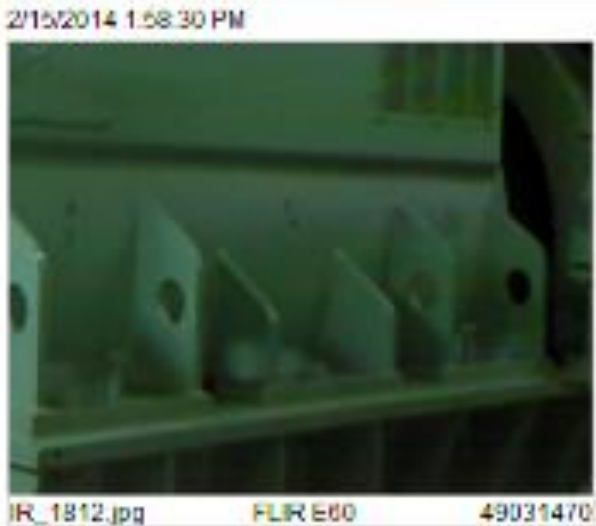
Note
ALTERNATOR WITH HIGH TEMPERATURES

A diesel generator alternator showing high temperatures can cause damages loss of alternator life due to excess temperatures

Measurements		
Ar1	Max	106.1
	Min	92.1
	Average	102.6
Ar2	Max	107.8
	Min	83.3
	Average	102.1
Ar3	Max	107.0
	Min	85.4
	Average	100.3
Sp1		105.9

Parameters	
Emissivity	0.95
Ref. temp.	20 °C

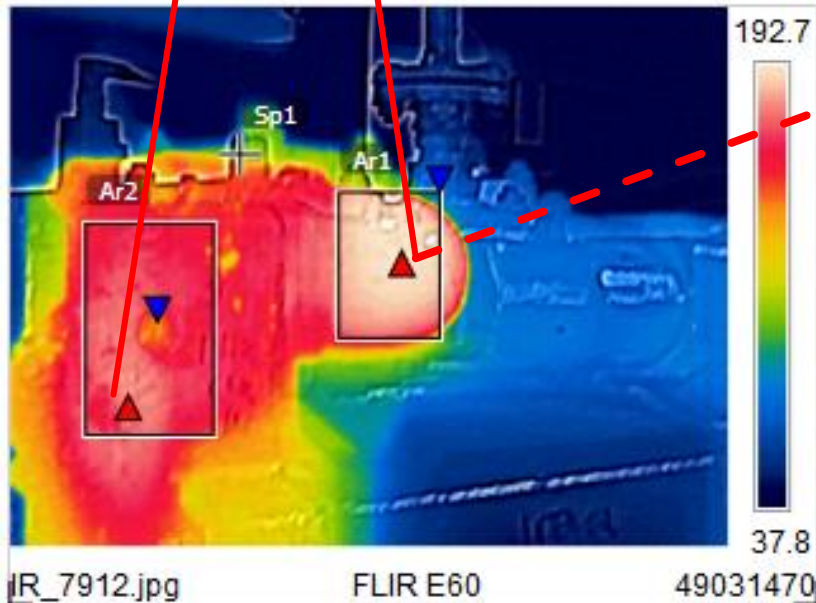
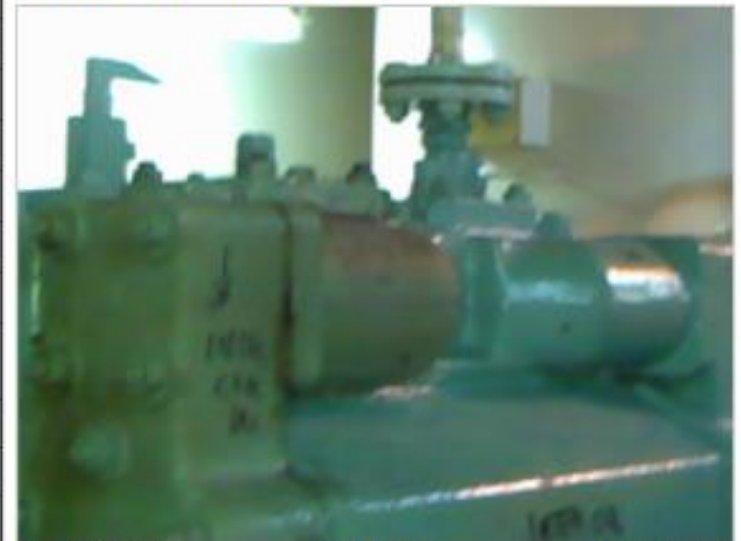
Main start Air compressor onboard running very hot with LP discharge inlet to inter cooler about 194.2°C reduce the efficiency, long running hours and damage to many components like valves, coking in inter after coolers etc.,

Measurements °C		
Ar1	Max	194.2
	Min	65.2
	Average	182.5
Ar2	Max	180.6
	Min	142.5
	Average	169.6
Sp1		109.4
Parameters		
Emissivity		0.94
Refl. temp.		35 °C
Note		
lp disch into intercooler

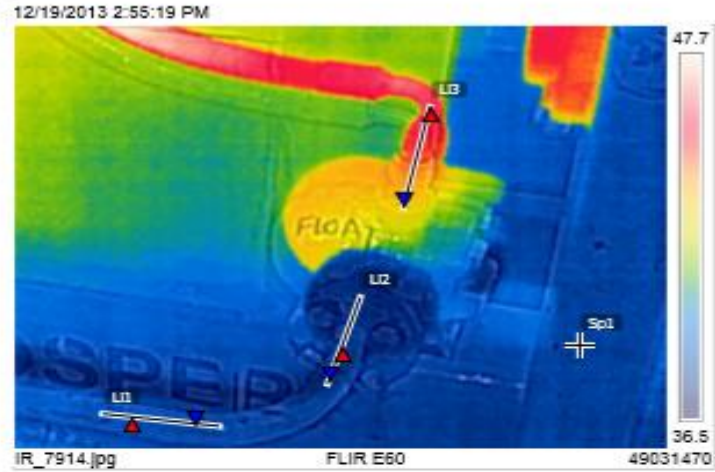
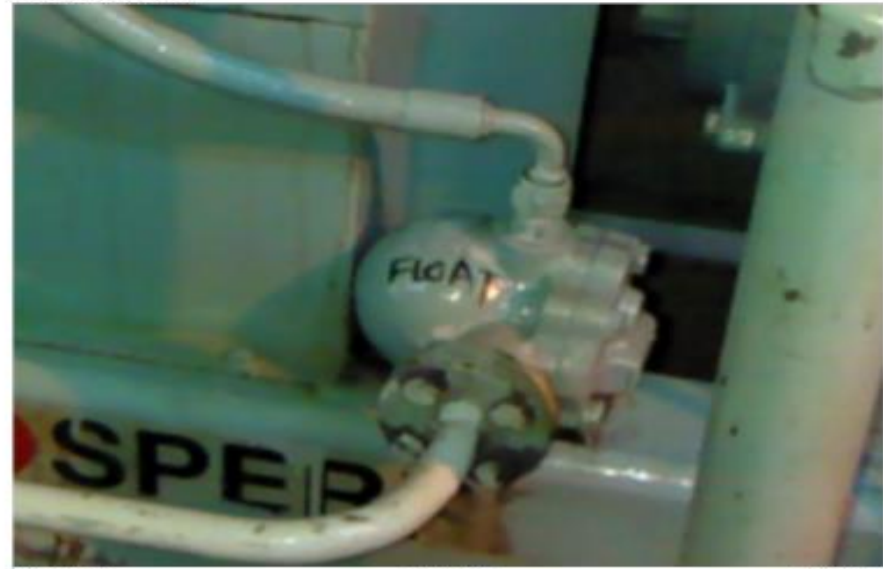
Measurements			°C
Sp1			38.1
LI1	Max		38.6
	Min		38.0
	Average		38.3
LI2	Max		38.1
	Min		37.5
	Average		37.9
LI3	Max		45.8
	Min		42.5
	Average		44.2
Parameters			
Emissivity			0.95
Ref. temp.			20 °C
Note			
to drain after 15mins running

THE INTER COOLER DRAIN WAS CHECKED MANY TIMES AFTER THE COMPRESSOR STARTED FOR THE DRAINOUT THROUGH THE FLOAT BUT NO EVIDENCE OF DRAIN FLOW NOTICED.

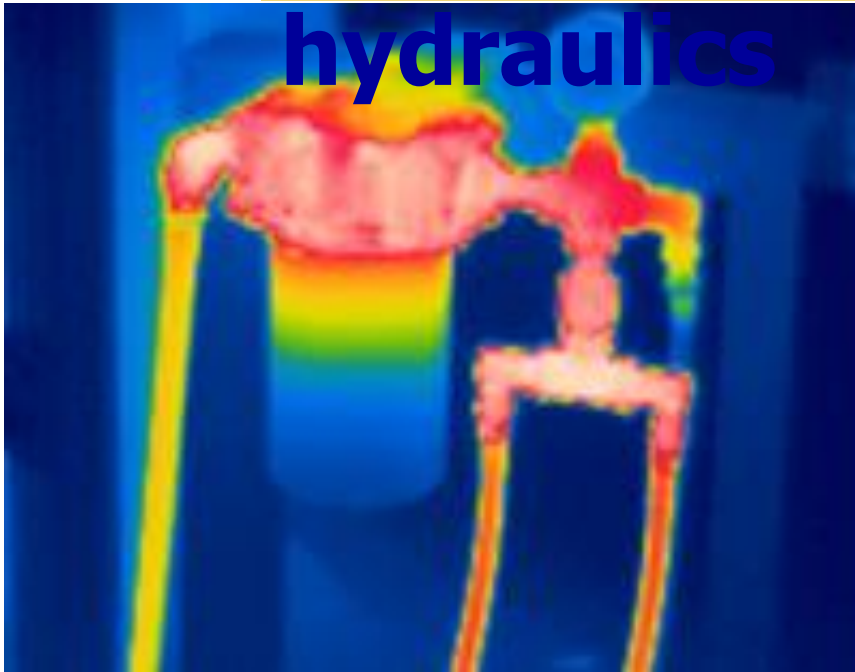
A blocked filter top side hot oil flowing, bottom side cooler and showing no oil flow (blockage) through filter.

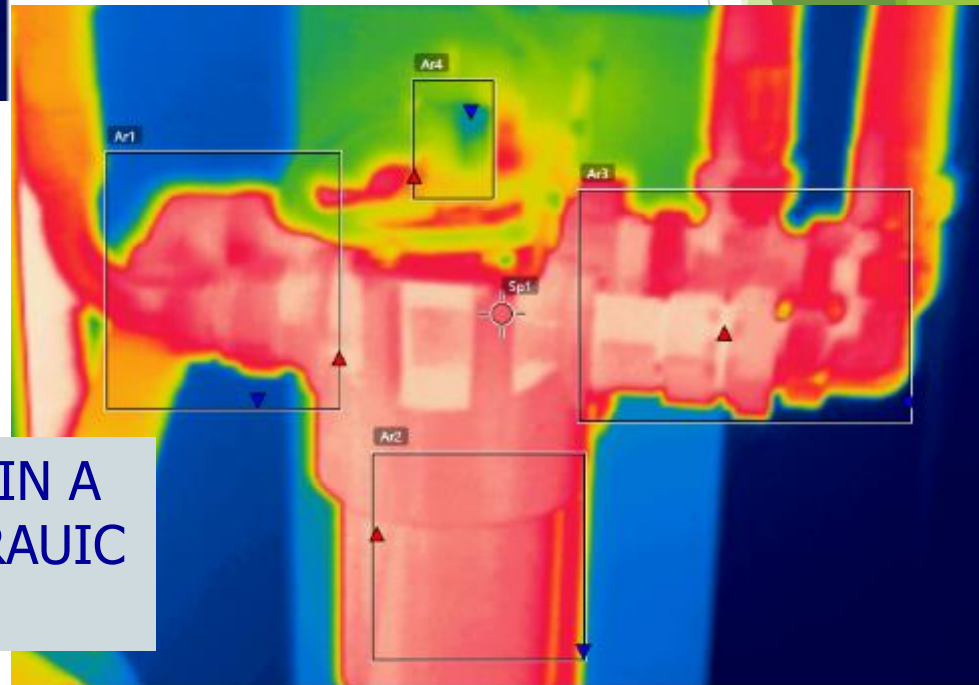
A good filter IN A
CRANE HYDRAUIC
SYSTEM

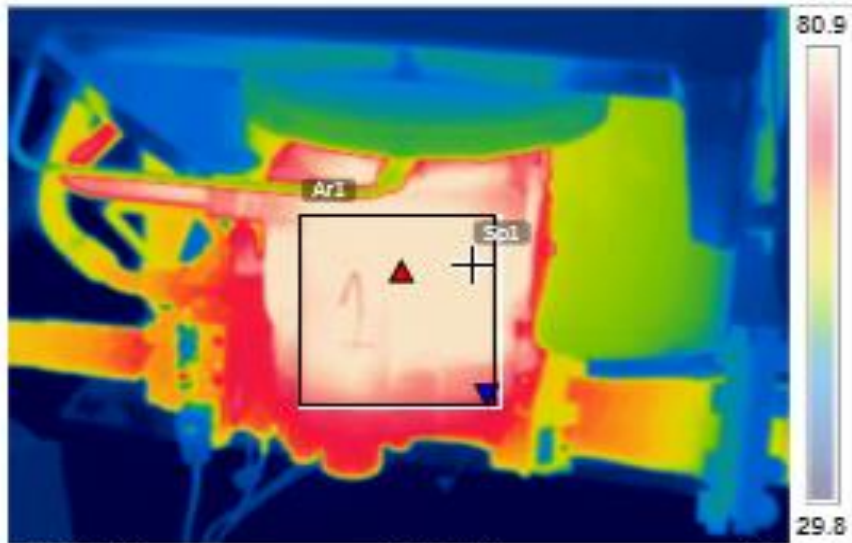
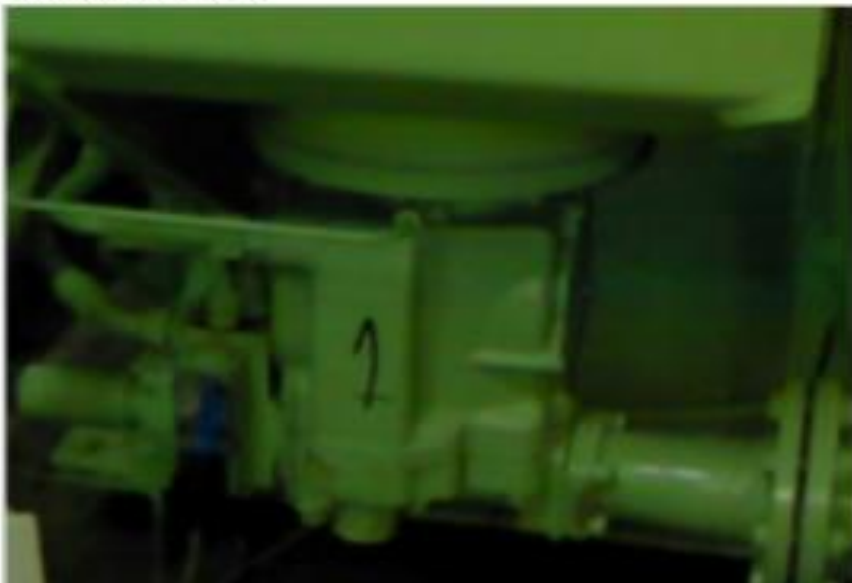
NOTE:
 THE HYDRAULIC PUMP HEATED UP TO 83.2°C WITHING 30 MINS OF OPERATION WINDLASS HEAVING ANCHOR INDICATING OVER HEATING OF PUMP DUE TO OIL QUALITY OR COMPONENTS LIFE DETERIORATION.

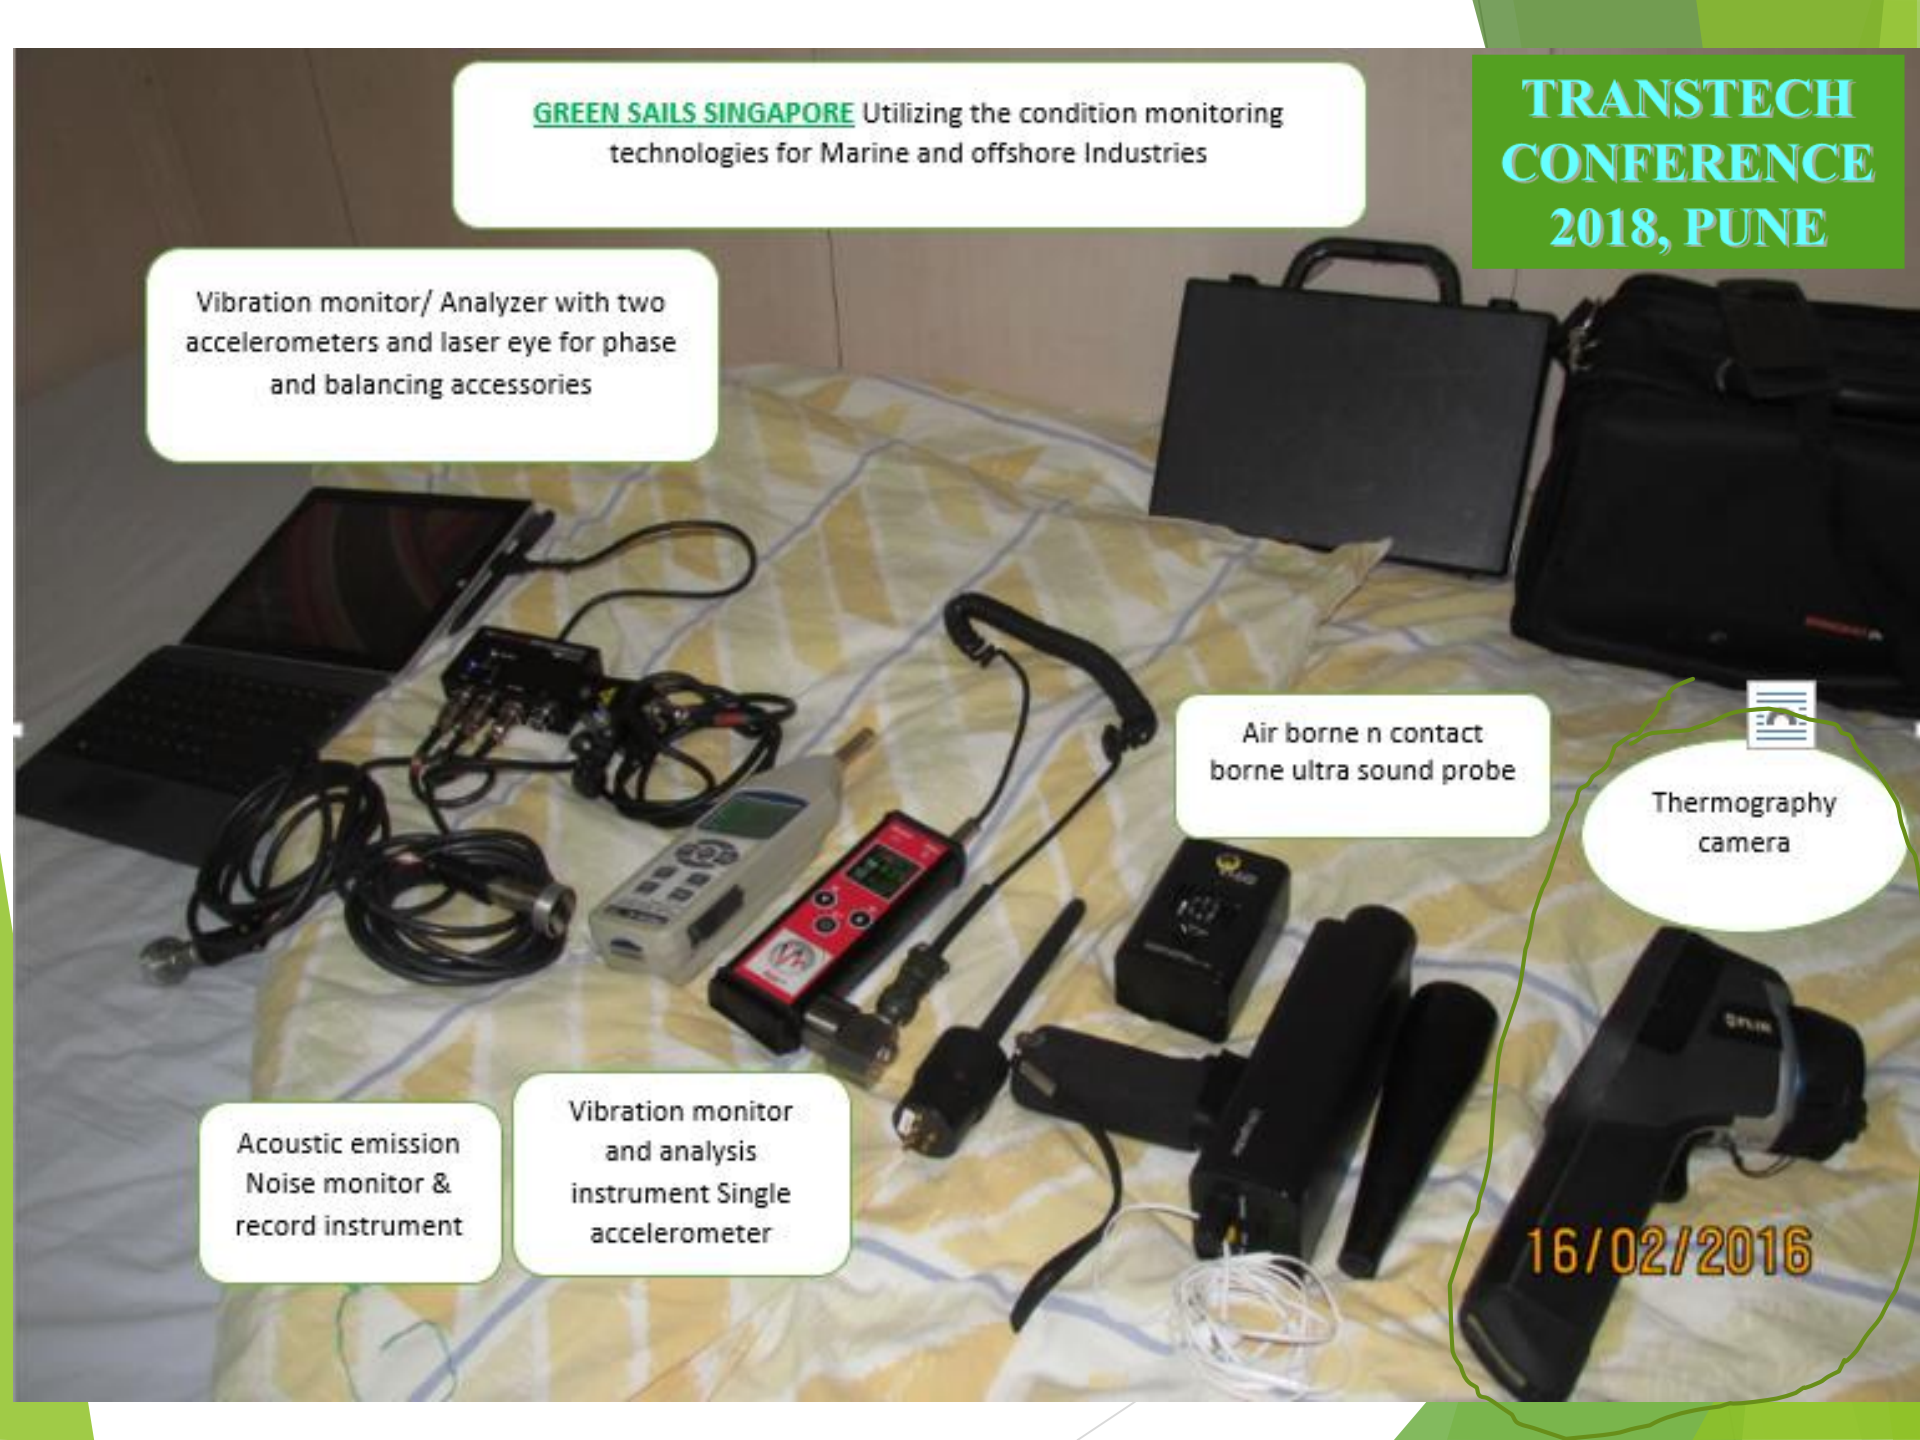
Vibration monitor
and analysis
instrument Single
accelerometer
